THE TSUNAMI OF NOVEMBER 29, 1975 IN HAWAII

HAROLD G. LOOMIS

DECEMBER 1975

HAWAII INSTITUTE OF GEOPHYSICS
UNIVERSITY OF HAWAII, HONOLULU

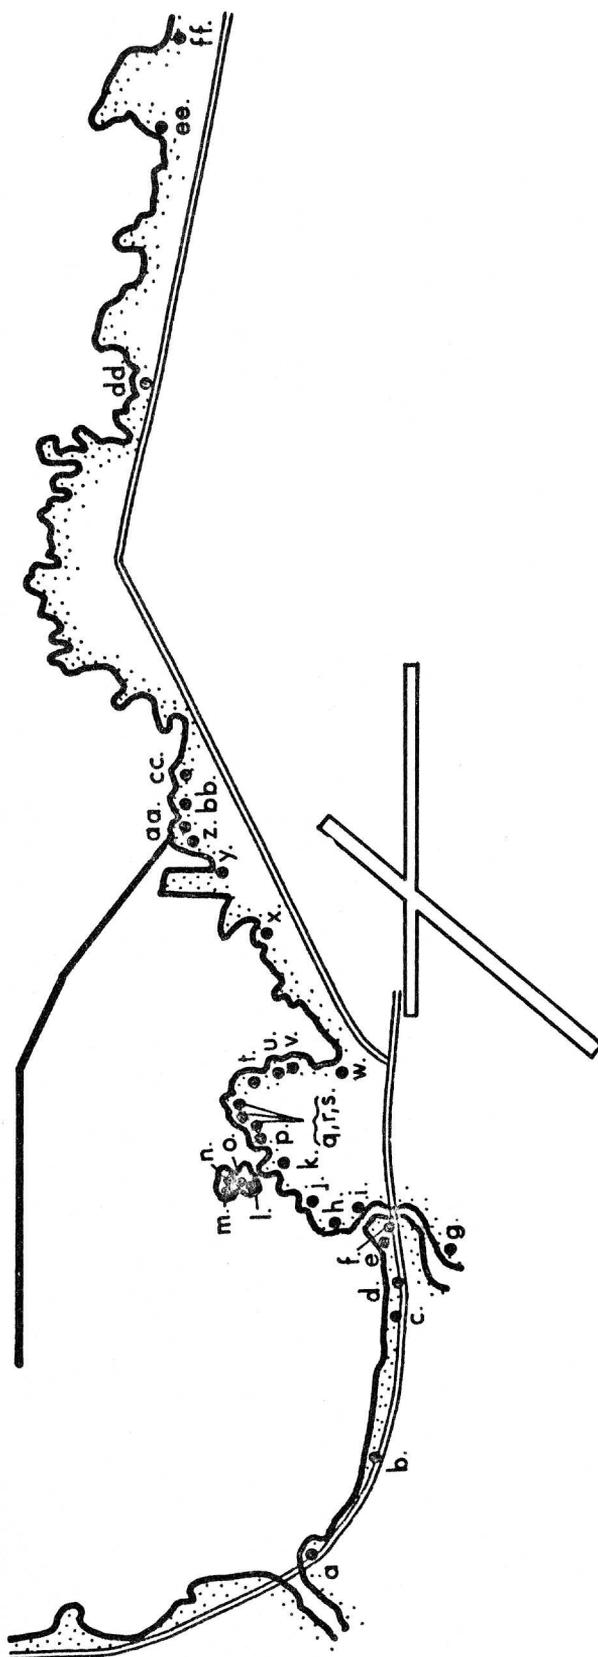
Figure 3. Location of measurements at Hilo; some symbols refer to Table 1.

Location	Symbol ¹	Measurement		Approximate distance from water's edge	Runup measurement		Correction		Evidence
		Date	Time		Yards	Feet	Feet	Feet	
Light at Wailuku River	a	11/30	1720	10	9.1	-0.6	8.5	Debris on ground	
Start of guard rail at intersection	b	11/30	1713	10	8.8	-0.6	8.2	Do.	
At canoe clubs	c	11/30	1635	20	7.9	-0.4	7.5	Do.	
100 yards east of symbol c	d	11/30	1640	20	7.9	-0.4	7.5	Do.	
Left bank entrance to Wailoa River	e	11/30	1705	20	8.8	-0.4	8.4	Do.	
Inside entrance, above parking lot	f	11/30	1655	20	8.3	-0.5	7.8	Do.	
At telephone stand, dock area, same level along docks	g	11/30	1615	5	5.5	-0.4	5.1	Silt on cement base of telephone stand	
Marine railway by Suisan	h	12/1	0950	15	7.7	-0.7	7.0	Debris on tree	
Rock wall toward river, inside at Suisan	i	12/1	1000	5	5.8	-0.7	5.1	Debris in rock wall	
Rock wall by Liliuokalani Garden	j	12/1	0930	10	5.1	-0.8	4.3	Debris	
To left of road leading to Coconut I.	k	12/1	1710	30	4.6	+0.2	4.8	Debris, log

Coconut I. bridge	l	12/1	1735	40	5.0	0	5.0	Debris, seaweed	
Seaward side of comfort station	m	12/1	0740	8	7.4	0	7.4	Seaweed in trees	
Seaward right side of Coconut I.	n	12/1	0745	10	6.6	0	6.6	Debris on grass	
Water just tops wall	o	12/1	0750	1	6.1	0	6.1	Debris	
Right of road to Coconut I.	p	12/1	0725	20	5.5	0	5.5	Debris, seaweed	
Front of Hilo Lagoon Hotel	q	12/1	0630	5	4.1	+0.4	4.5	Debris

Location	Symbol ¹	Measurement		Approximate distance from water's edge	Runup measurement		Correction		Corrected measurement	Evidence
		Date	Time		Yards	Feet	Feet	Feet		
Front of Hilo Lagoon Hotel	r	12/1	0815	5	4.3	0	4.3	0	4.3	Debris
Front of Hilo Lagoon Hotel	s	12/1	0815	5	4.3	0	4.3	0	4.3	Do.
Naniloa Hotel	t	12/1	0832	5	4.0	-0.3	3.7	0	3.7	Do.
Naniloa Hotel	u	12/1	0845	5	4.7	-0.4	4.3	0	4.3	Do.
Naniloa Hotel	v	12/1	0850	5	2.8	-0.4	2.4	0	2.4	Do.
Reeds Bay, by road	w	12/1	0910	10	4.3	-0.7	3.6	0	3.6	Do.
West of pier 2, 50 yards	x	12/1	1120	5	3.6	-1.2	2.4	0	2.4	Do.
Radio Bay at Coast Guard Cutter	y	11/30	1343	0	3.5	-0.4	3.1	0	3.1	Testimony followed by measurements. "Boats bottomed during wave."
East end of Radio Bay	z	11/30	1400	10	3.3	-0.4	2.9	-5.0	2.9	Debris on grass. Pine needle swash marks.
Just outside breakwater	aa	11/30	1415	10	6.9	-0.4	6.5	0	6.5	Do.
Outside breakwater, 100 yards east	bb	11/30	1430	10	6.7	-0.4	6.3	0	6.3	Do.

Outside breakwater, 200 yards east	cc	11/30	1435	10	6.8	-0.4	6.4	0	6.4	Do.
James Kealoha Park	dd	11/30	1352	5	4.7	-0.4	4.3	0	4.3	Bagasse, flattened grass
Leleiwi Park	ee	11/30	1530	20	5.5	-0.4	5.1	0	5.1	Swash in pine needles
End of road, 4 miles	ff	11/30	1520	30	6.0	-0.4	5.6	0	5.6	Do.

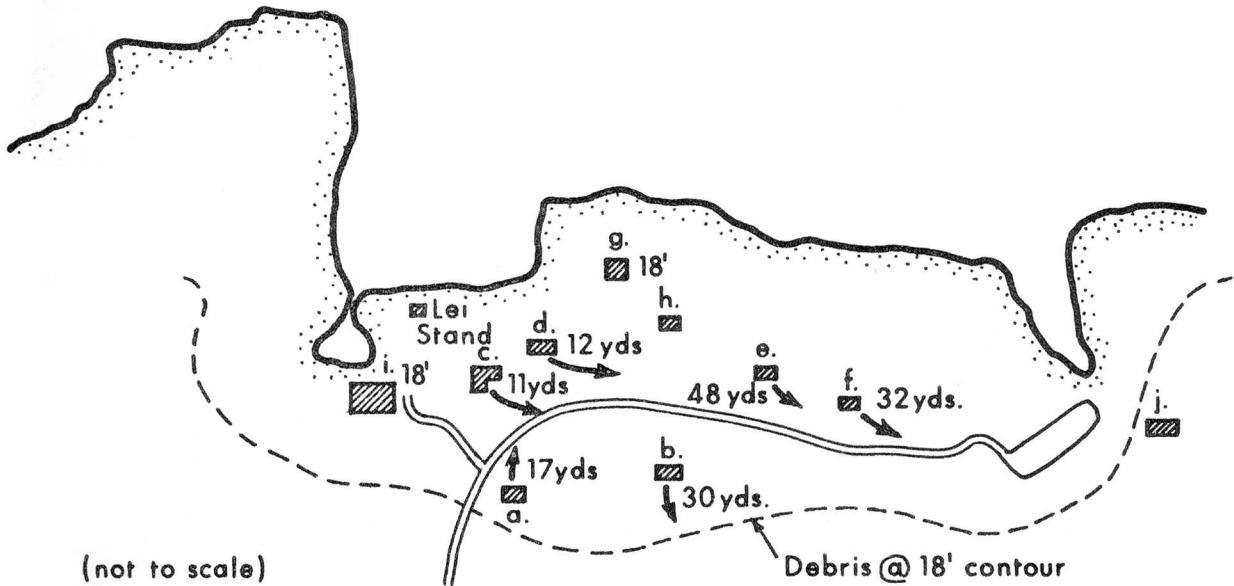
Figure 4. Punaluu, Kau, Hawaii showing houses destroyed.

³ Wave height taken from contractor's elevation plan. Almost uniformly 18-foot contour. Marks on pavilion near water's edge were 18 feet also.

- a. Ito house destroyed, moved 17 yards toward sea.
- b. House nearly intact, moved 30 yards inland.
- c. Dahlberg house, mostly destroyed, rotated 90° clockwise, moved 11 yards to right then seaward 5 yards.
- d. Carmichel A-frame house destroyed, moved 12 yards to right.
- e. Mizuno house shattered, moved 48 yards,
- f. Cacholoa house shattered, moved 32 yards.
- g. Pavilion fence down and roof lifted.
- h. Small tile buildings destroyed.
- i. C. Brewer restaurant gutted.
- j. Golf house basement filled, golf carts flooded.

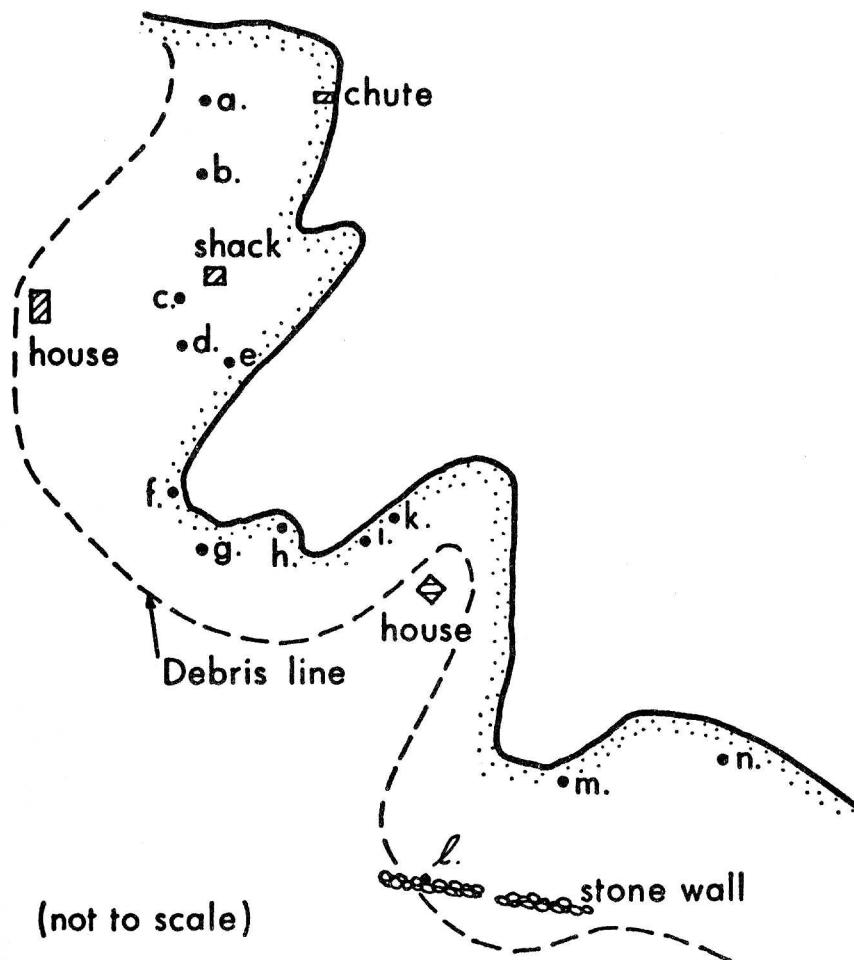
Figure 5. Kaalualu, Kau, Hawaii showing locations of measurements.

Location	Symbol ¹	Measurement		Approximate distance from water's edge	Runup measurement		Correction		Corrected measurement		Evidence
		Date	Time		Yards	Feet	Feet	Feet	Feet	Feet	
Kaalualu	a	12/3	0950	80	15.0	-0.6	14.4	Debris			
Kaalualu	b	12/3	0940	50	14.3	-0.5	13.8	Keawe tree marks			
Kaalualu	c	12/3	0935	40	16.4	-0.4	16.0	Do.			
Kaalualu	d	12/3	0930	20	14.8	-0.4	14.4	Do.			
Kaalualu	e	12/3	0932	10	14.9	-0.4	14.5	Do.			
Kaalualu	f	12/3	1002	2	12.0	-0.6	11.4	Do.			
Kaalualu	g	12/3	1010	5	13.2	-0.6	12.6	Do.			
Kaalualu	h	12/3	1018	5	13.5	-0.7	12.8	Do. (near wrecked boat)			
Kaalualu	i	12/3	1027	5	9.8	-0.8	9.0	Keawe tree marks			
Kaalualu	j	12/3	1036	40	11.8	-0.8	11.0	Do.			
Kaalualu	k	12/3	1146	60	11.1	-0.9	10.2	Do.			
Kaalualu	l	-	-	200				Stone wall knocked down			
Kaalualu	m	12/3	1125	5	15.2	-0.8	14.4	Keawe tree marks			
Kaalualu	n	12/3	1133	80	16.0	-11.0	15.0	Debris on grass
