“Lesson from 5 years continuous operation of DONET cabled observatory network”

Katsuyoshi KAWAGUCHI
Deputy Director

Research and Development Center for Earthquake and Tsunami
Japan Agency for Marine-Earth Science and Technology
(JAMSTEC)

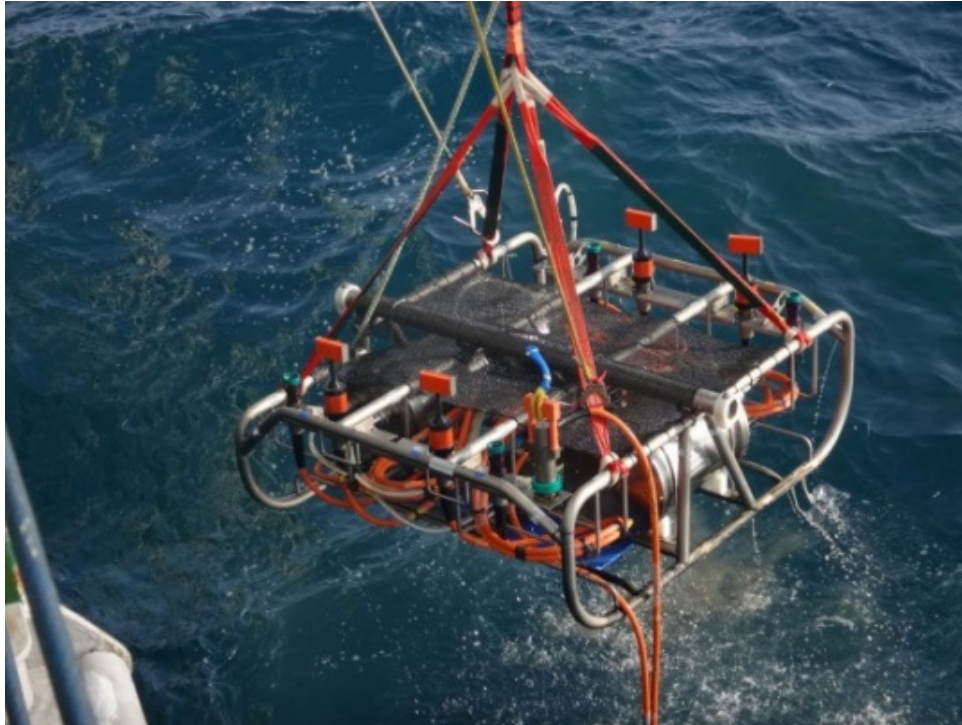
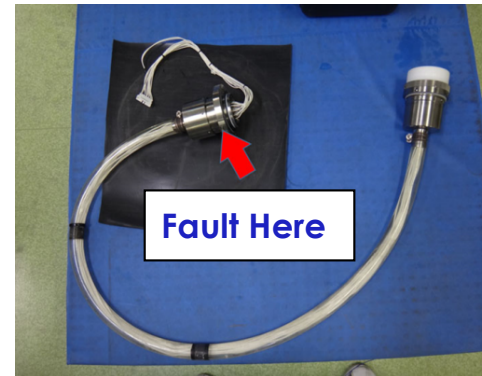
DONET science node after 4 years operation in seafloor

- Ground fault of oil filled connector harness

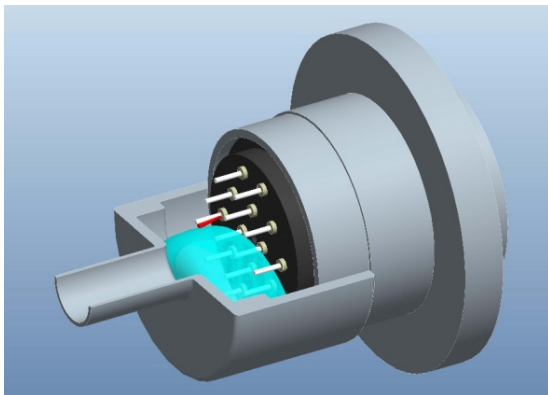
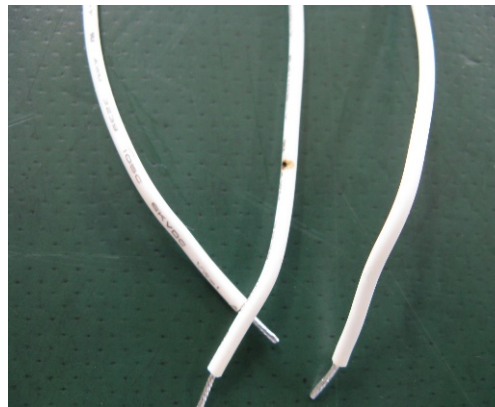
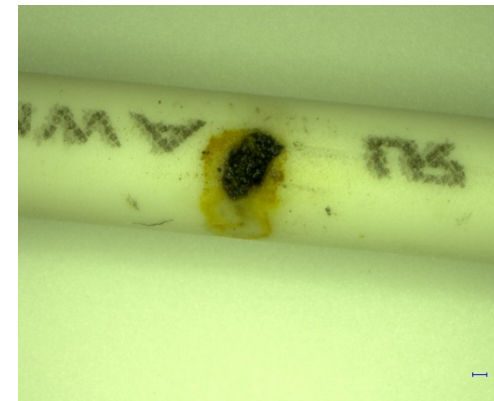
Two defect in one connector harness

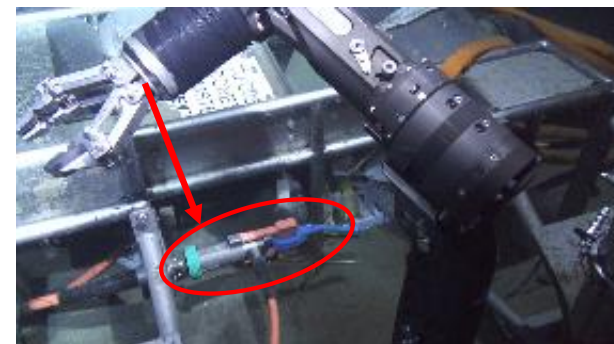
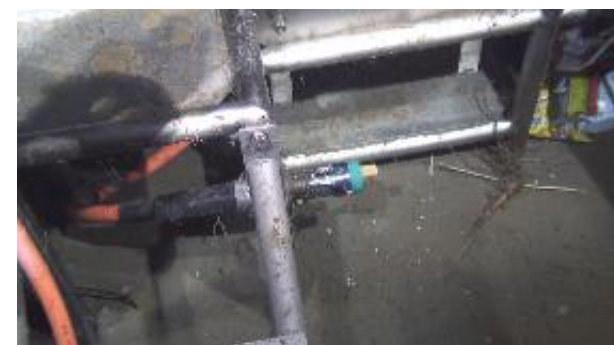
DONET1 TU-E(Terminal Unit)

Ground fault around Site E -> March 6, 2016
Confirmation of Node condition by ROV -> June 8, 2016

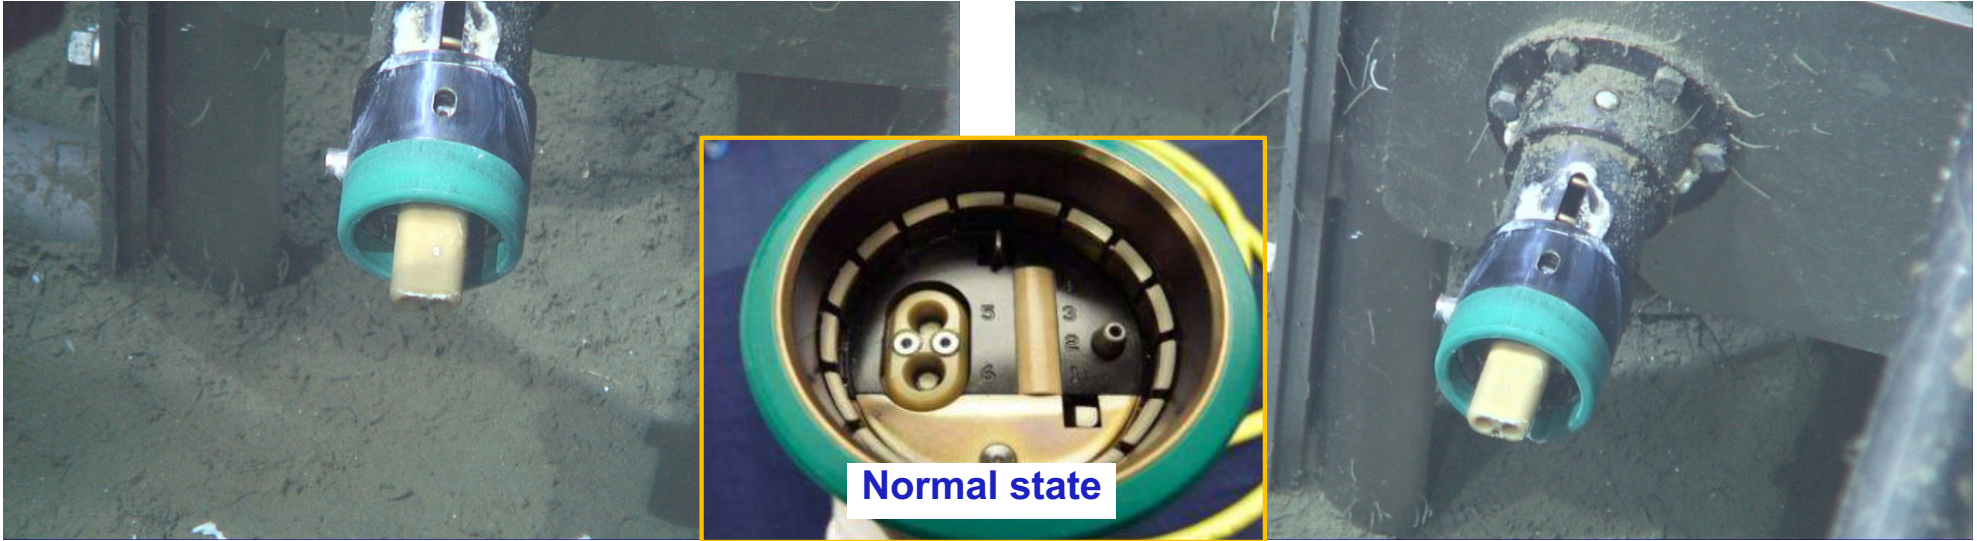
Terminal Unit E (TU-E) Side

Condition of UMC on TU-E (part of backbone cable system)
