Ocean observing Workshop Ocean networks Canada Barkley Node Trawl Event & Repair

Paul Macoun, ONC Field Operations Manager

3 January 2017

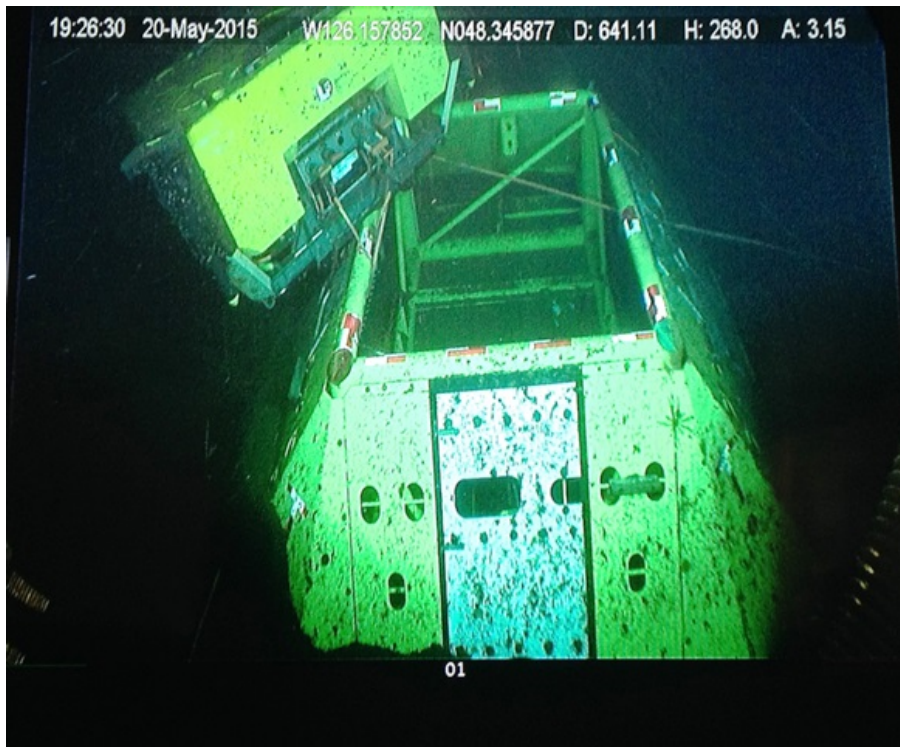
The Node hanging out of the TRF, all weight (~700 lbs) hanging on the science and communications cables

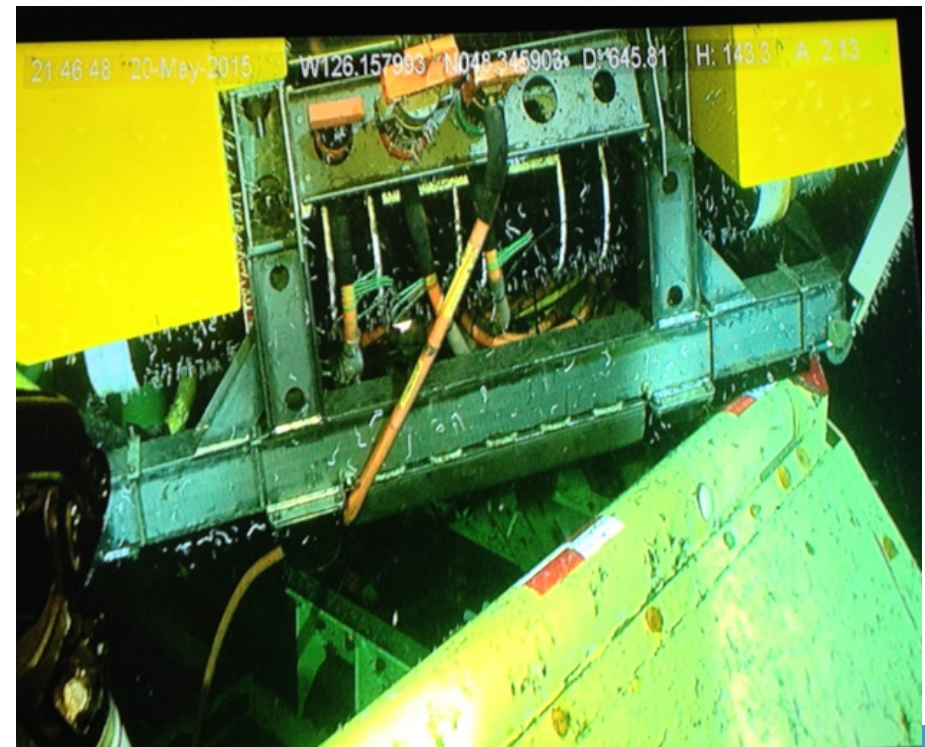
The Node after being repositioned to the top of the TRF by the ROV, just prior to unplugging of connectors

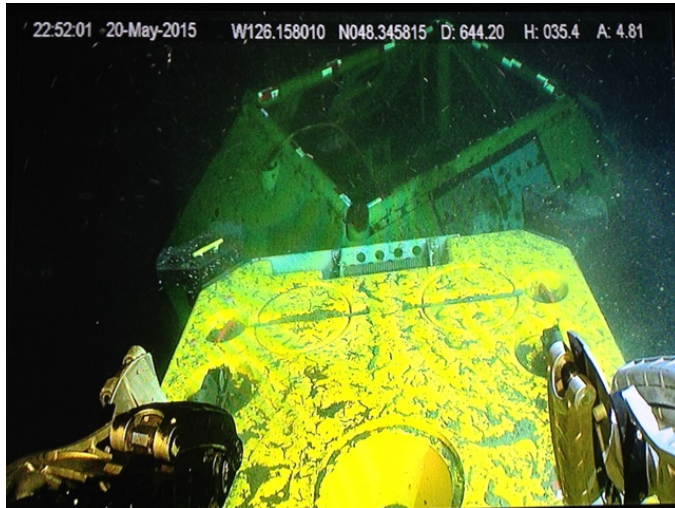
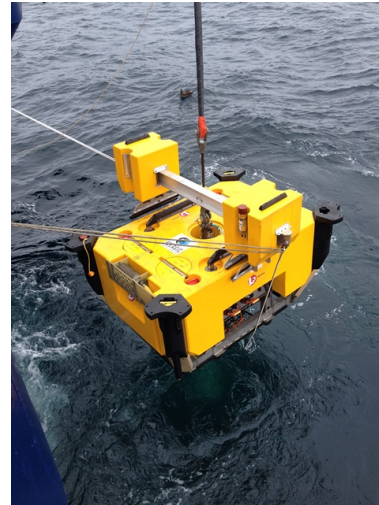
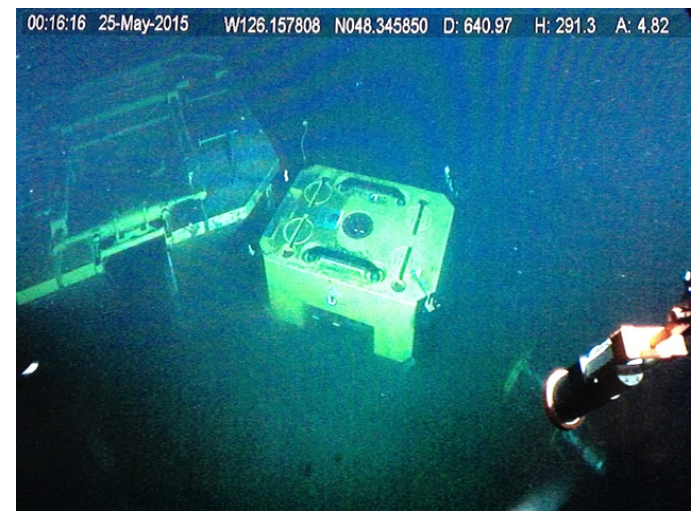
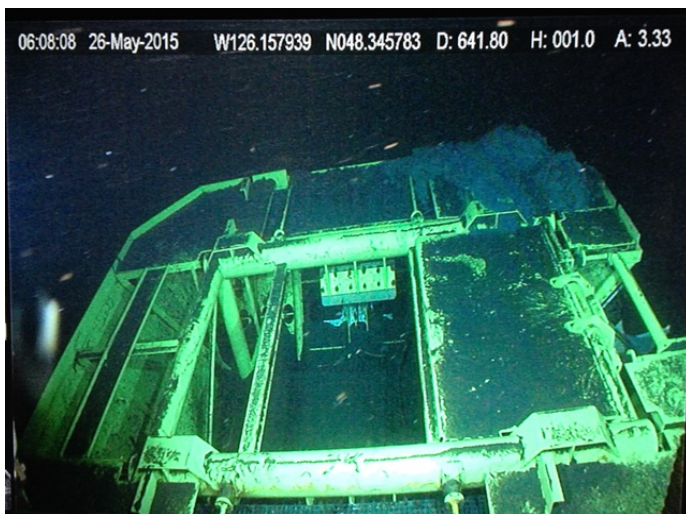
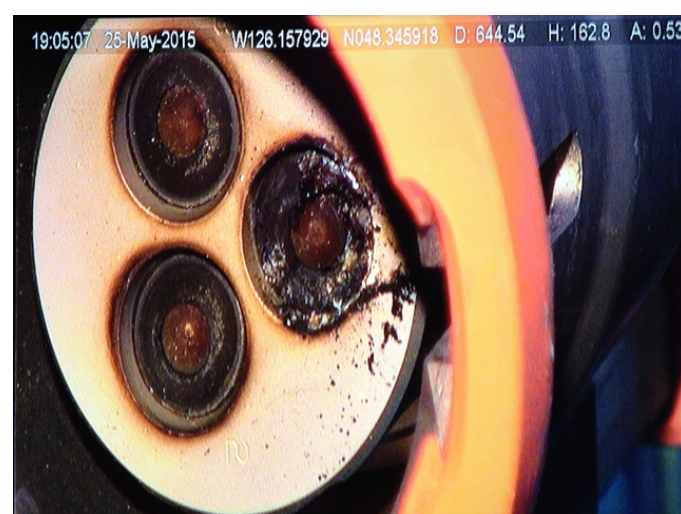
Description: Repair Operation (May 2015)

- ❑ Fibre in connector hose damaged (main communications)
- ❑ Fibre in science cables damaged
- ❑ CTA replaced, and spare Node deployed (outside TRF)
- ❑ Wet mate-able HV connector failed on power up
- ❑ TRF accidentally flipped and subsequently recovered, along with Barkley and Spare Nodes (May 2015)
