# OOI Cabled Array: Vertical Mooring Shallow Profiler

Eric McRae

Applied Physics Laboratory

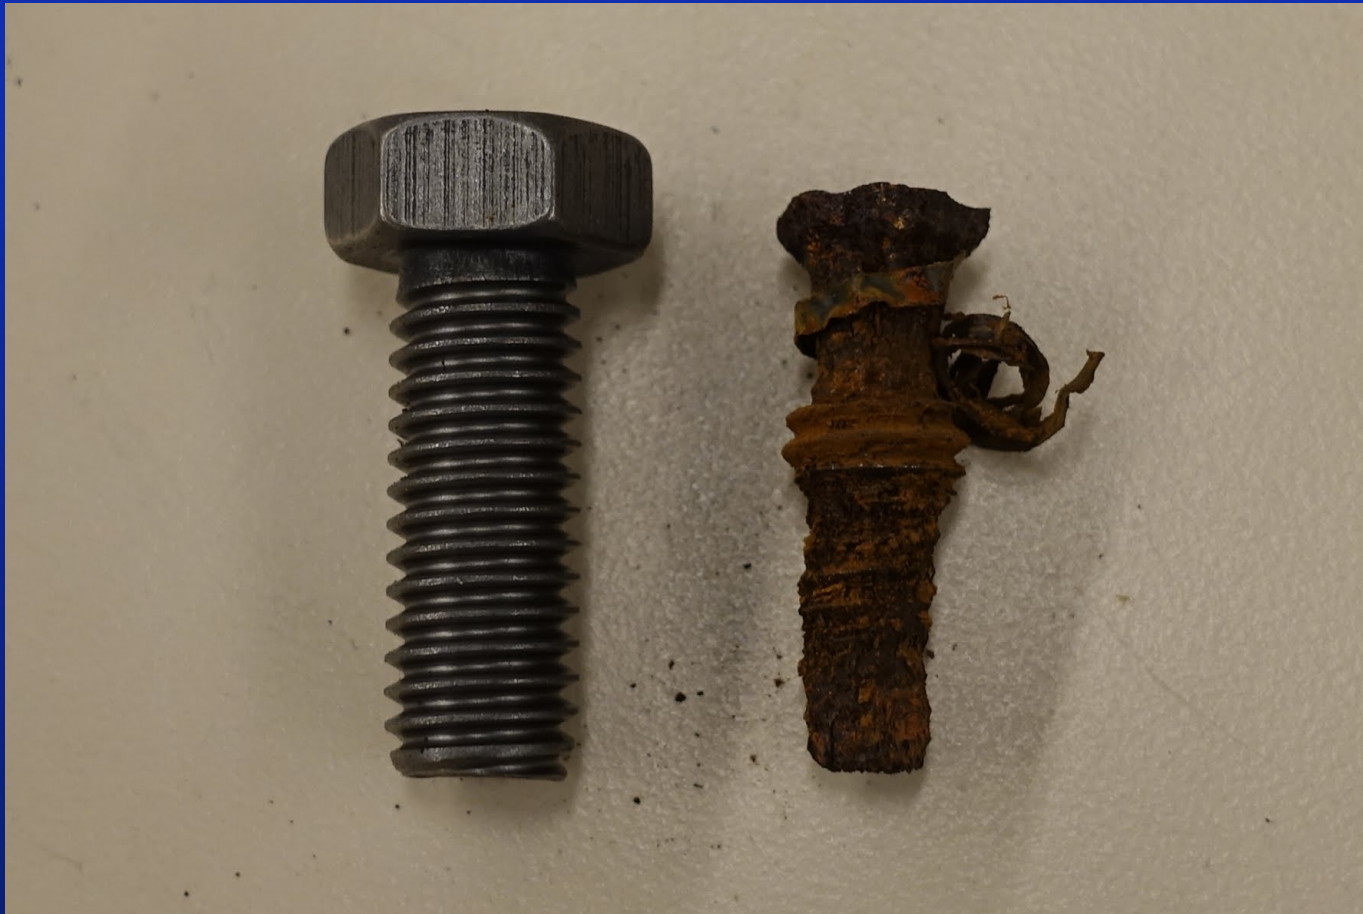
Description: Wet metal is supposed to be Titanium. Sometimes SS bolts have been used. The two are difficult to tell apart.

Problem: Mixing Metals

Description: Different metals in contact create a Voltaic junction. Adding salt water allows a conduction path resulting in one of the metals getting eaten!

1. All parts bins are color coded and labeled:  
Yellow = SS  
Red = Titanium
2. All unidentified loose parts are discarded.
3. All assemblers are trained.
4. Assemblies are inspected after salt water tests.

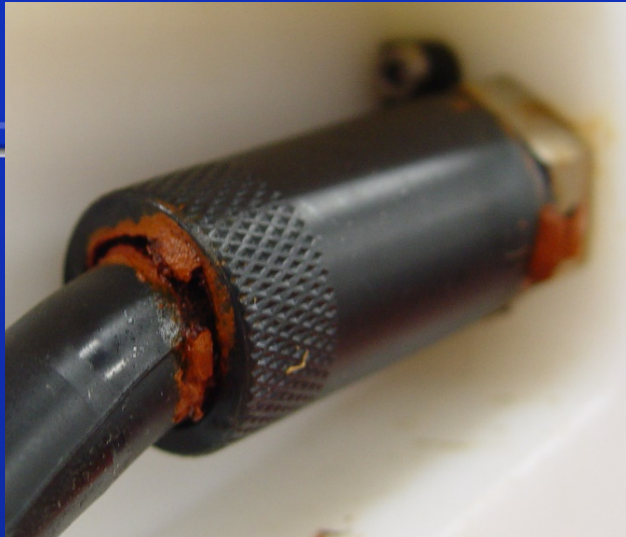
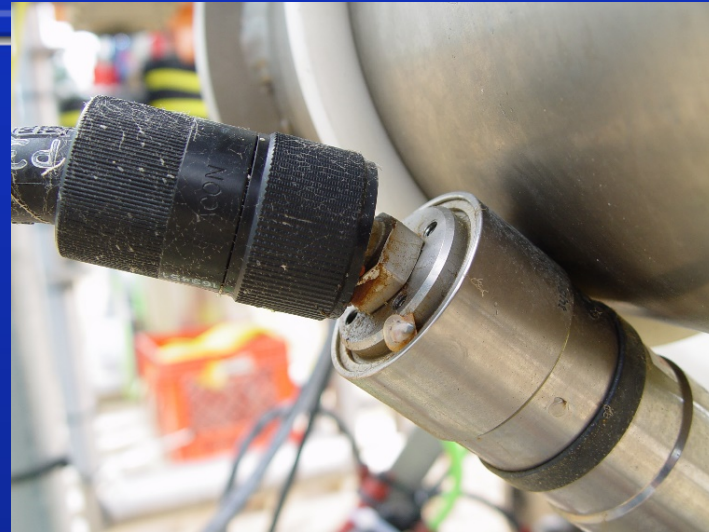
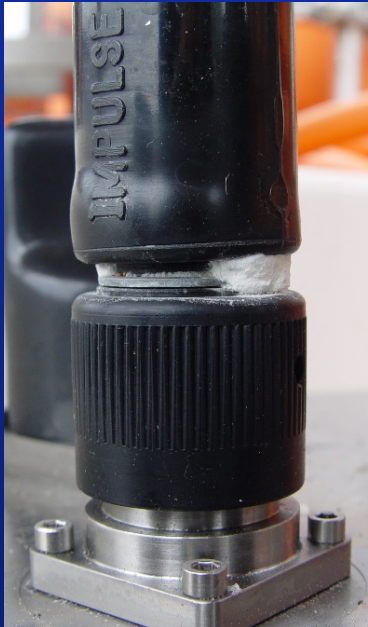
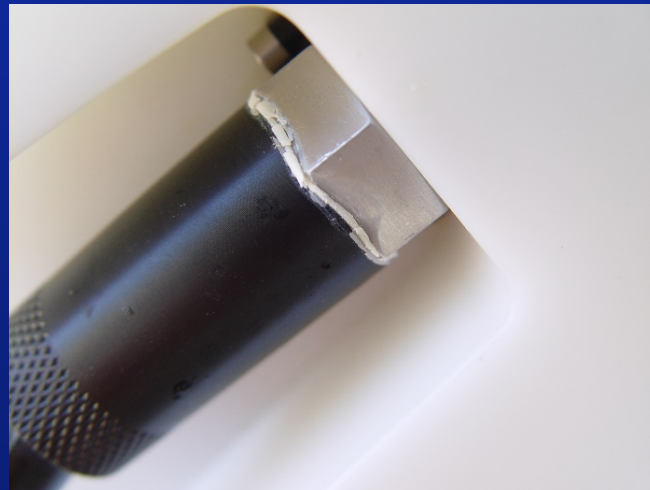
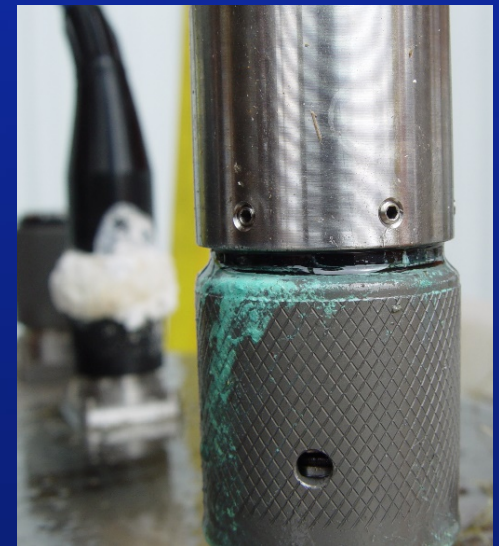
Problem: Many connectors failed after deployment

Description: Vendor changed recipe for molding compound without notification.

Solution: Require vendor re-certification or local review for any changes in product

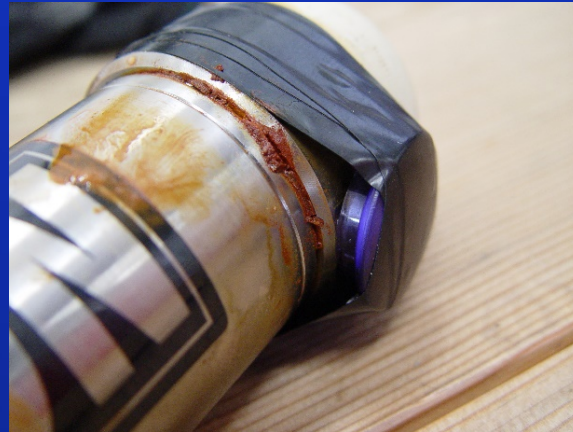
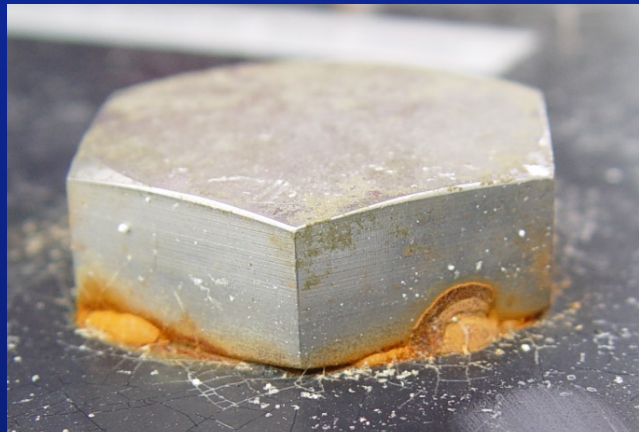
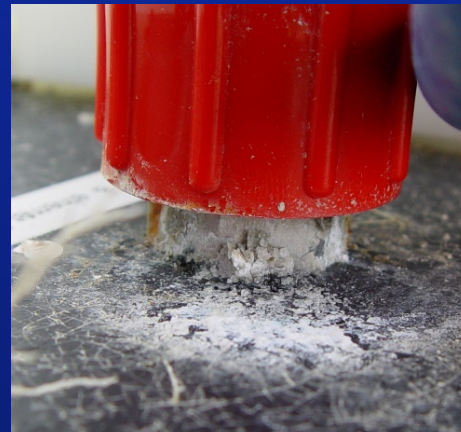
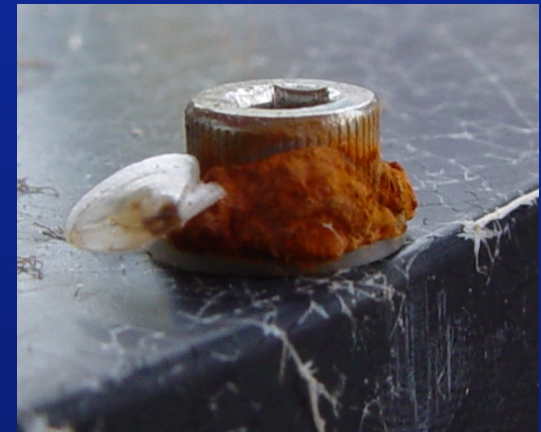
Problem: Devices difficult to assemble. Connectors difficult to connect

Description: 0 for 6 on beacons and flashers in 2015 due to assembly. Many connectors very difficult to correctly assemble in actual use.

Solution: Evaluate connectors and devices for actual use

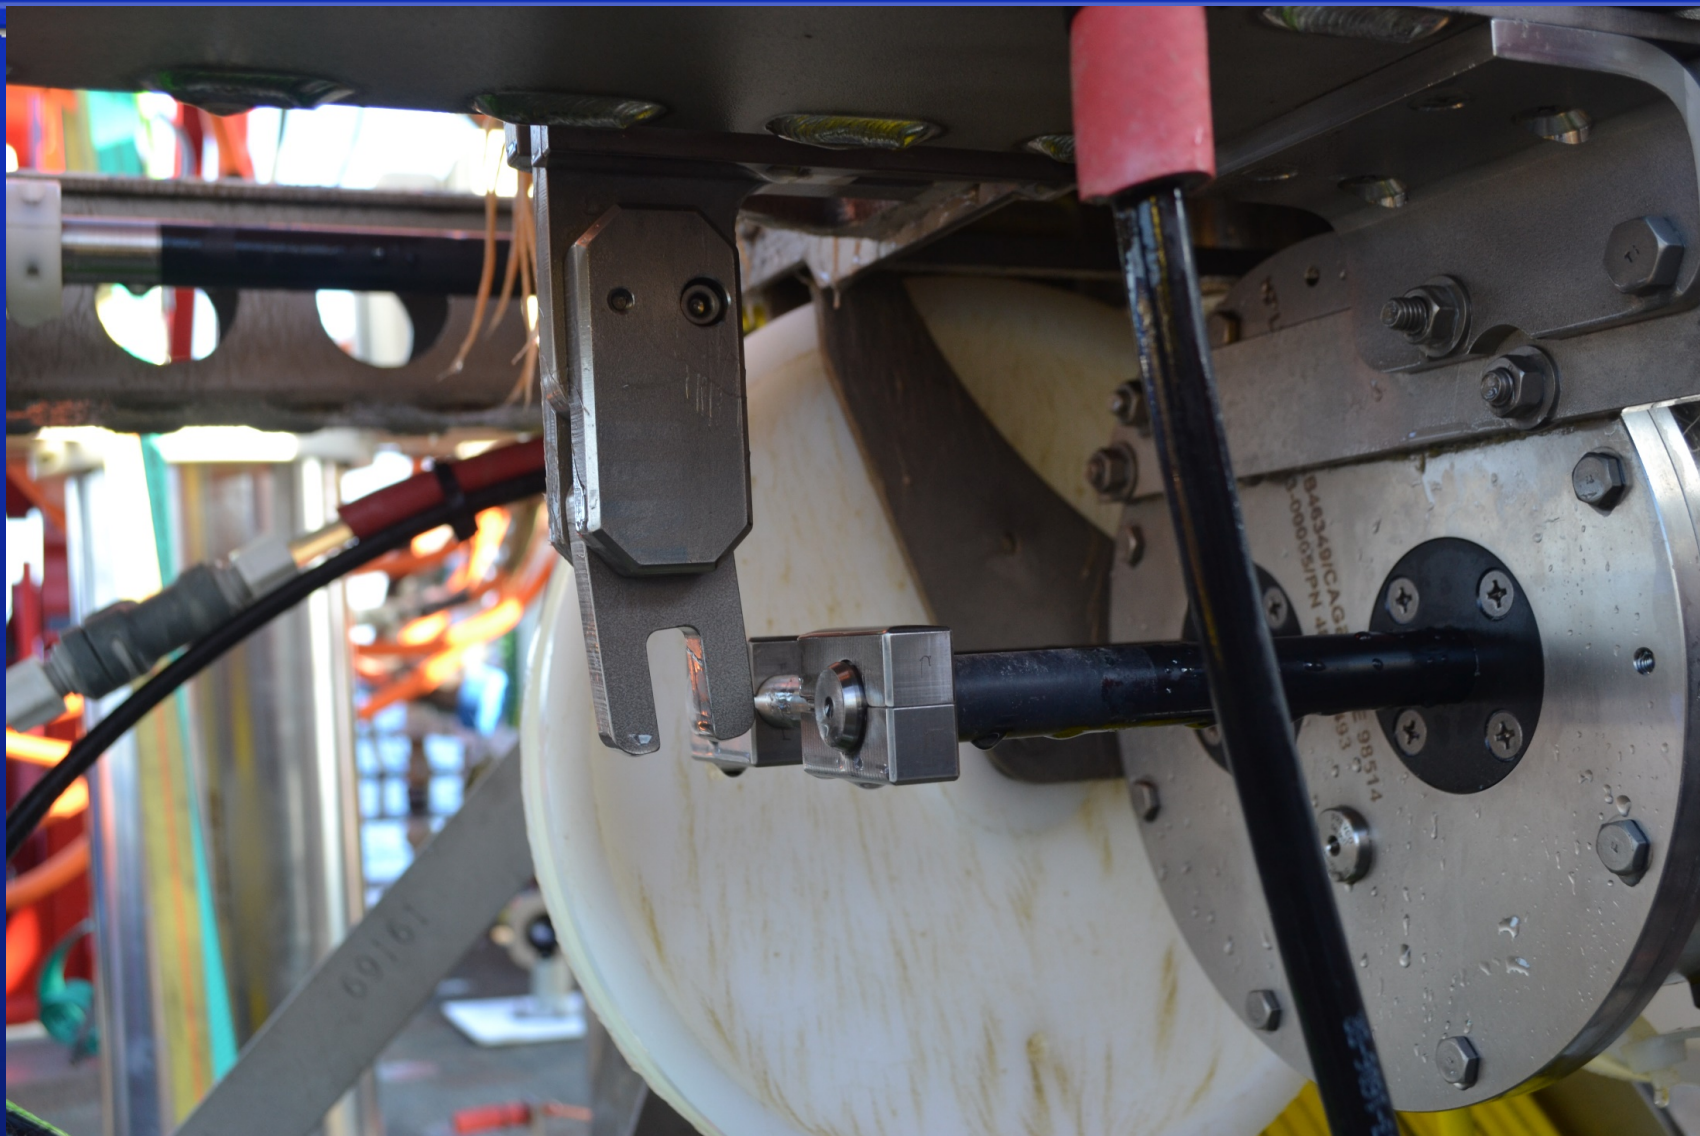
Problem: Mechanical failure of shear pin.

Description: Levelwind shear pin designed for 500 lbs break strength sheared probably due to Science Pod being moved at air/sea IF or possibly by ROV

Solution: Strap/latch Science Pod securely for deployment (In Design)
