DAM AND RESERVOIR FAILURES (19)

B Teton Dam

GG303

III Teton Dam

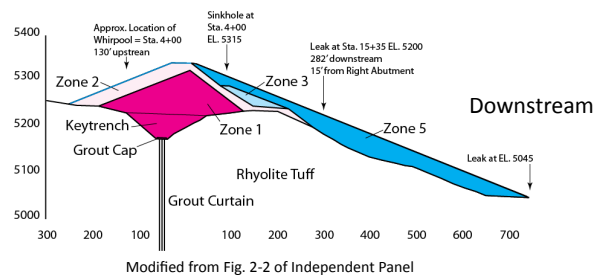
Section Along Approximate Path of Failure

- 2 Dimensions: Maximum height: 101 m (305'); Crest length: 945 m (3100')
- 3 Zoned earth fill dam
 - a Zone 1: Silt for dam core. With some caliche.
 - b Zone 2: Mix of fines, sand, and gravel for drainage. To control seepage through foundation.
 - c Zone 3: Mix of clay, silt, sand, and rock for downstream shell (structural stability)
 - d Zone 4: River sands and gravel. For upstream toe and cofferdam (not shown in diagram)
 - e Zone 5: Cobbles and boulders, and rock fragments. For outer shell (armor).
- 4 Keytrench. Excavated to remove highly fractured rock near ground surface.
- 5 Grout curtain. Injections along vertical holes with 3m (10') spacing. Intended to seal joints.
- 6 Grout cap. Intended to seal base of keytrench.

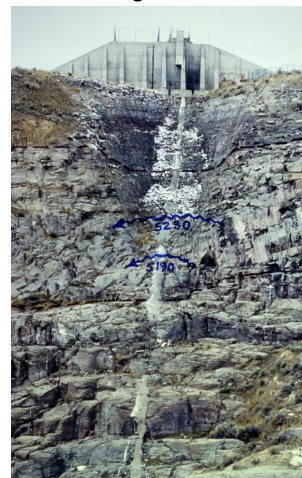
Joints in Right Abutment

- 1 Seismic hazards
- 2 Joints in rhyolite
 - a Steep
 - b Subhorizontal
 - c Apertures of 1 cm to 2+m
- 3 Piping hazard
recognized: silt (loess)
fill in Zone 1 was highly
erodible

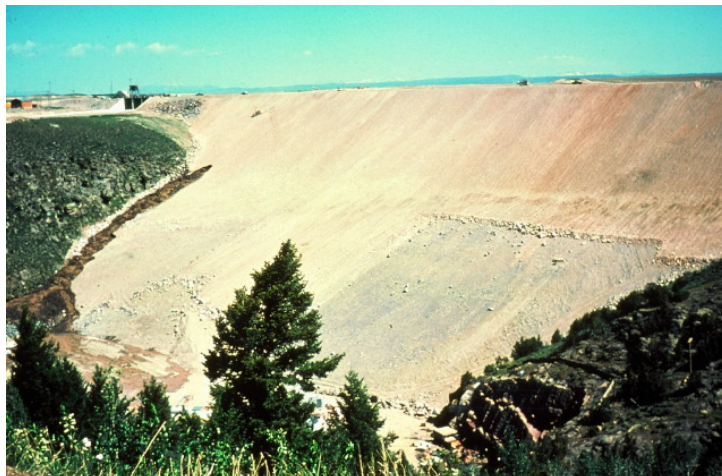
~10:30 AM

Note D-9 bulldozer heading down to upper leak. Another leak at toe.

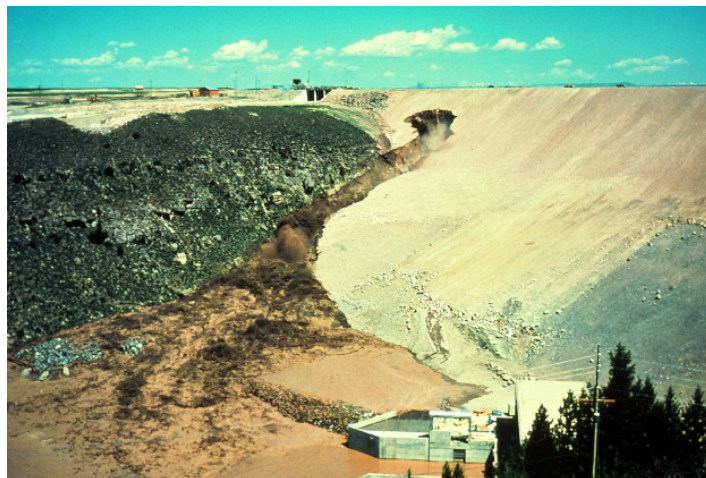
~11:30

Outlet works being flooded

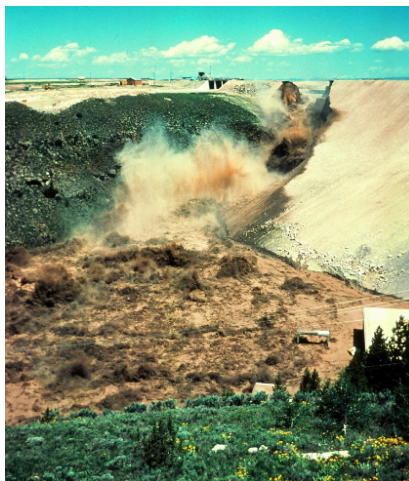
11:57

Dam is breached

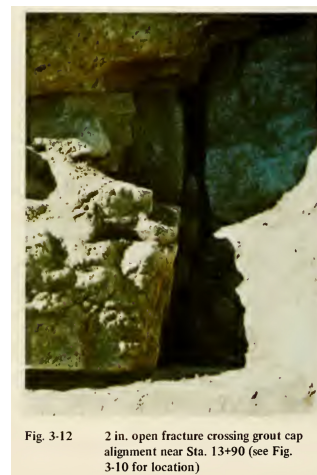
- a Seismic activity did not cause failure
- b Many joints in key trenches were open
- c Grouting did not seal all fractures
- d Flowing water could come into contact with silt core

Fig. 3-12 2 in. open fracture crossing grout cap alignment near Sta. 13+90 (see Fig. 3-10 for location)

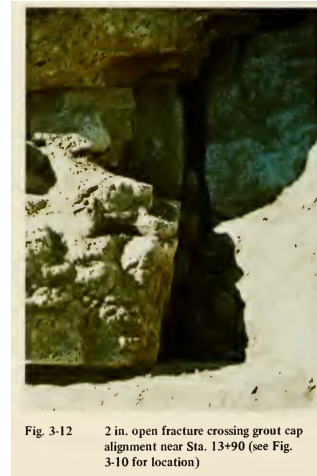
- a Remnant Zone 1 fill
uniform and well
compacted
- b Tests showed water
could flow through grout
cap and grout curtain
- c Excavations showed
some open joints passed
through grout curtain

Fig. 3-12 2 in. open fracture crossing grout cap alignment near Sta. 13+90 (see Fig. 3-10 for location)

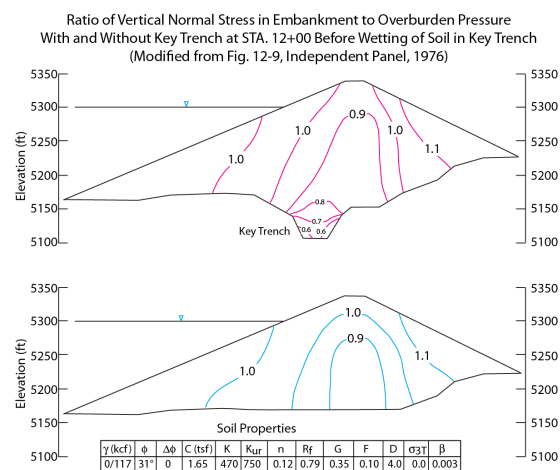
- 1 Poorly compacted fill found in key trench; stress analyses predict low compressive stresses in key trench

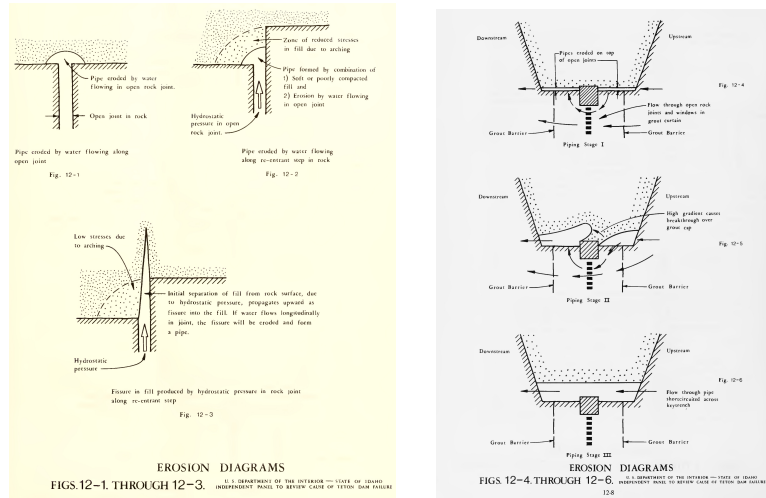
- 2 Water flowing in open joints eroded and fractured the silt fill, probably aided by hydraulic fracturing

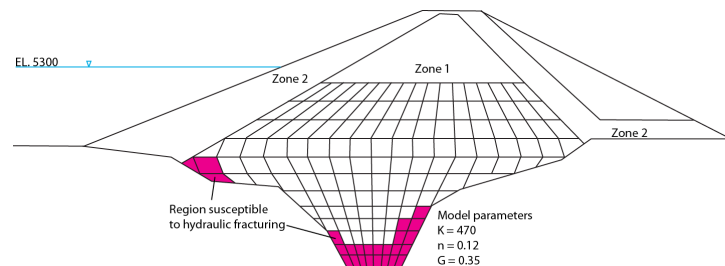
- 3 Stress analysis revealed parts of Teton Dam were susceptible to hydraulic fracturing

Model results showing portions of Teton Dam susceptible to hydraulic fracturing based on least compressive stress in plane of cross section
Modified from Independent Panel (1976), Fig. 12-11.
