## Papohaku Beach, Molokai - Erosion Analysis

Coastal Geology Group  
University of Hawaii Manoa  
February 2005

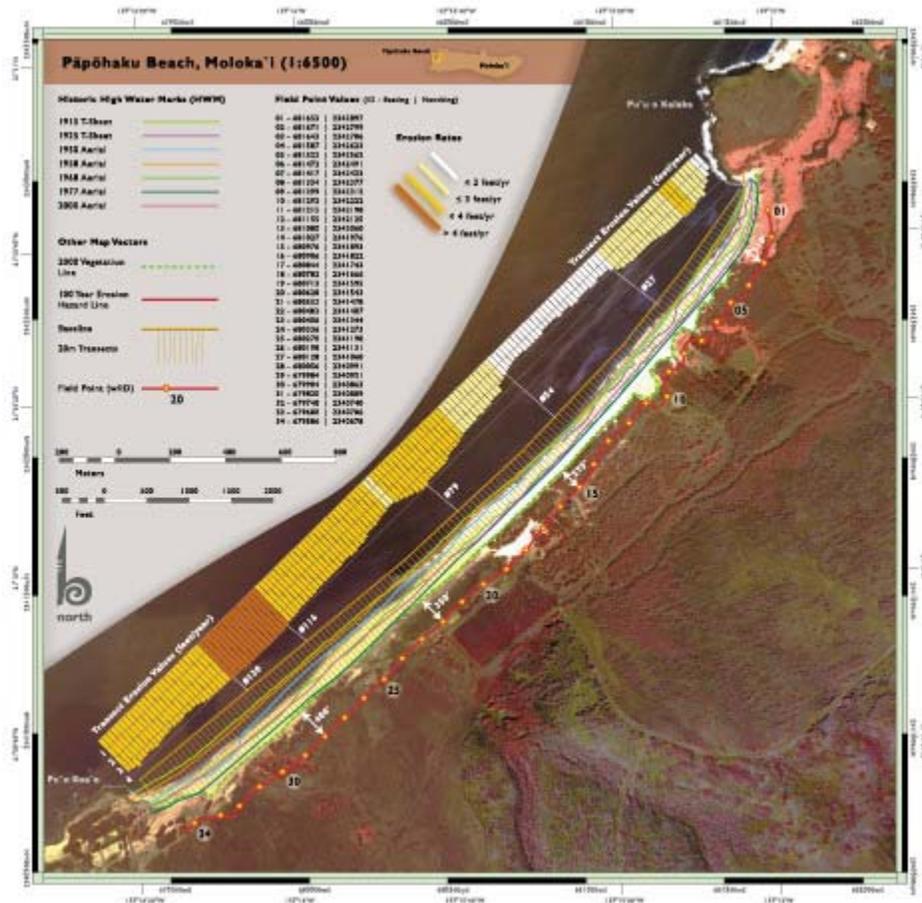
**Project Results:** Analysis results are displayed in the following poster.

**Poster includes:**

- 2000 aerial photo base image
- Historic HWM shoreline vectors
- Baseline and Transects
- Erosion values (ft/yr) associated with each transect
- 2000 Vegetation Line
- 100 Year Erosion Hazard Line with spot coordinate pairs to guide possible field work
- Additional relevant map elements

**Projected Hazard Line:** A 100 year erosion hazard line was produced by projecting the 2000 vegetation line inland by the associated beach erosion rate (ft/yr erosion rate x 100 years). Points were generated every 100 meters along the hazard line for possible field use.

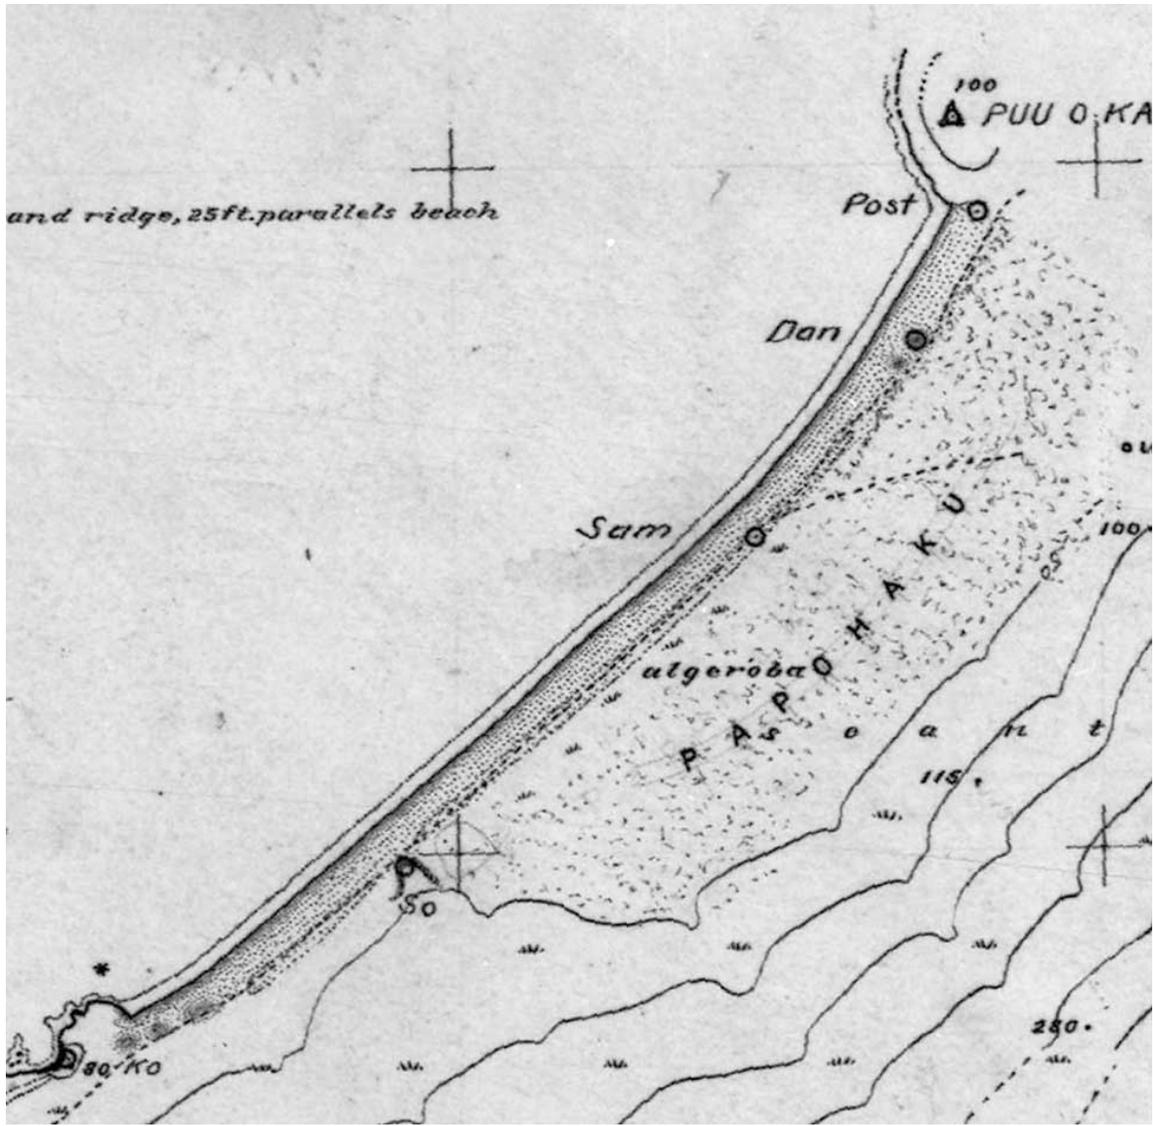
- **Topographic Survey (T-Sheet):** Survey Date: 1915
- **Rectification Notes:** Image rectified to the UTM Zone 4 North - NAD83 system (via 1<sup>st</sup> order polynomial w/ an RMS of 2.5m) utilizing visible graticules. Rectified image deemed suitable for use after t-sheet headland and control point locations were compared with modern day equivalents. Slight post-rectification adjustments were made to best match t-sheet control points to modern day control point array.
- **Image Notes:** Earliest Shoreline used in this study. Beach appears to have been surveyed during fuller width period (summer months) though no month is actually listed on T-sheet. Reference "*sand Ridge, 25ft. parallels beach*" appears on T-sheet – evidence of historic beach dune system. Vegetation listed as "algeroba". Heavy black shoreline used for erosion analysis.

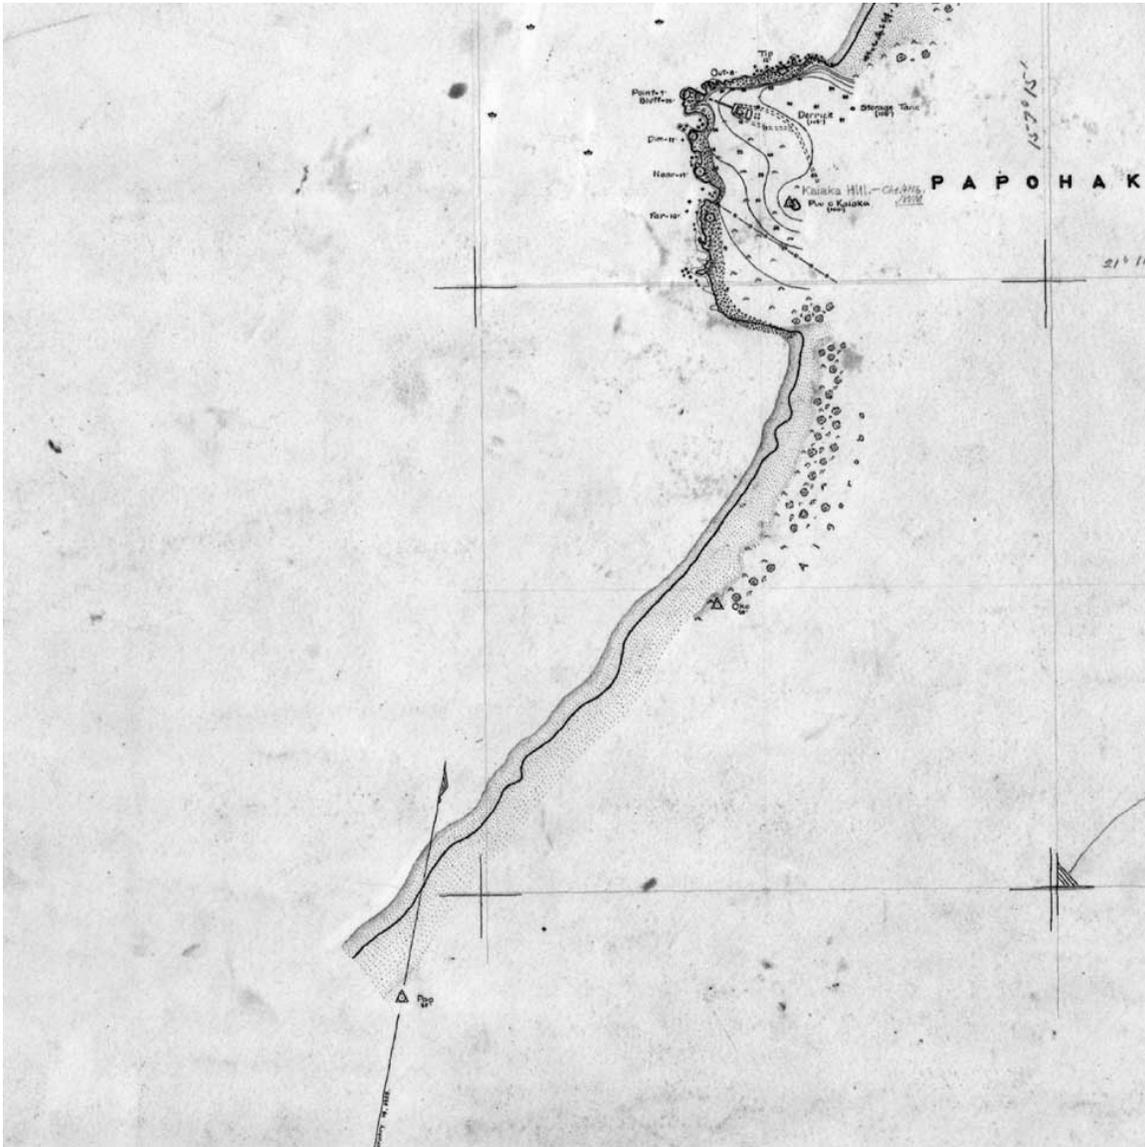
- **Topographic Survey (T-Sheet):** Survey Date: February, 1925
- **Rectification Notes:** Image rectified to the UTM Zone 4 North - NAD83 system (via 1<sup>st</sup> order polynomial w/ an RMS of 1.2m) utilizing visible graticules. Rectified image deemed suitable for use after t-sheet headland and control point locations were compared with modern day equivalents. Slight post-rectification adjustments were made to best match t-sheet control points to modern day control point array.
- **Image Notes:** More detailed survey than previous 1915 t-sheet but only covers northern portion of beach. Survey month (February) and cusped HWM line indicate possible winter seasonal erosion at time of survey. Vegetation listed as “algeroba”. Heavy black shoreline used for erosion analysis.

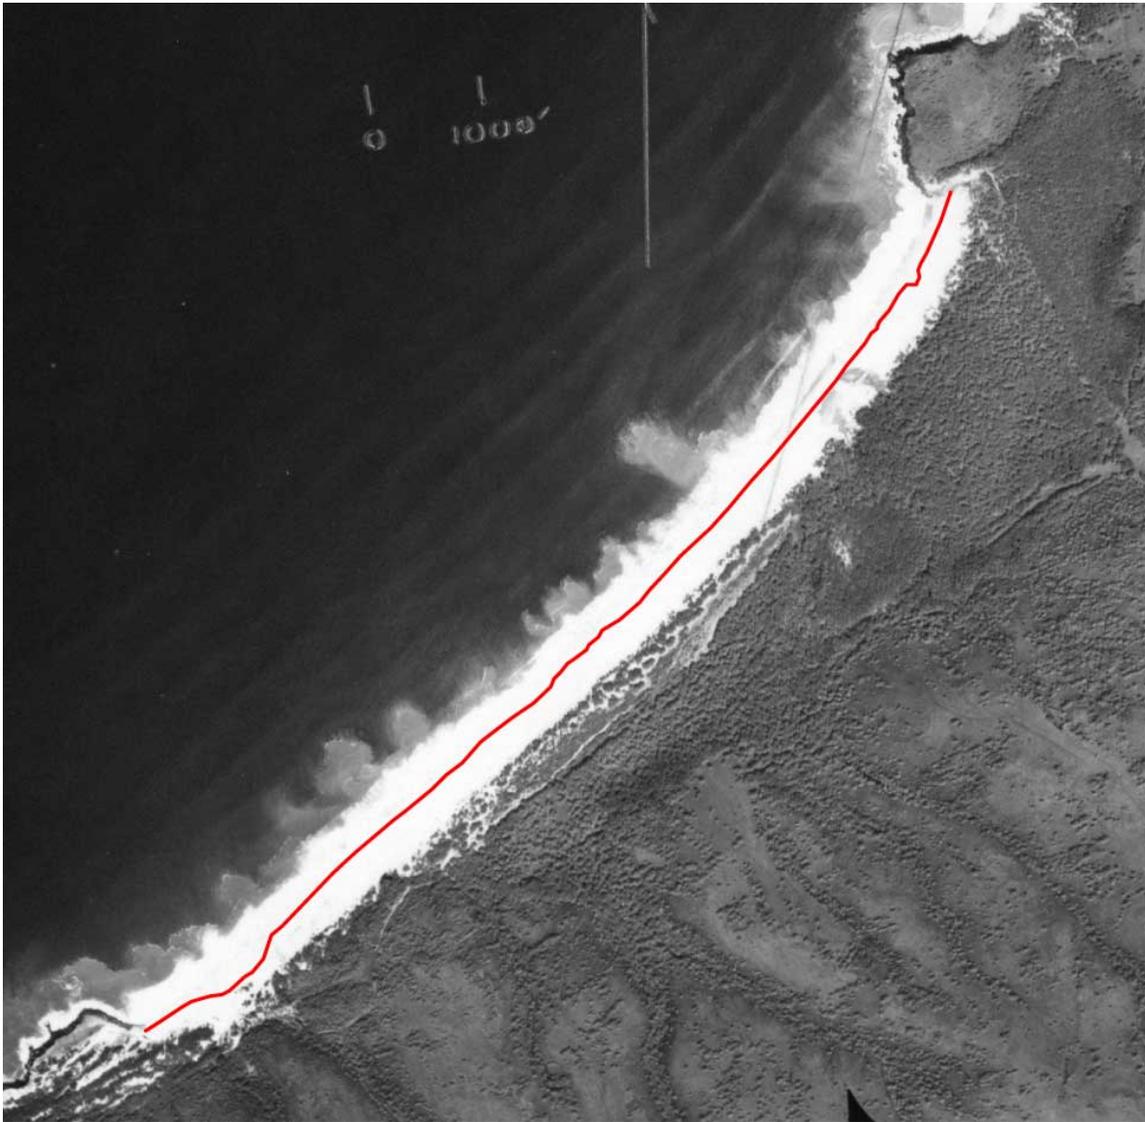
- **Aerial Photograph** - Photo Date: February 1<sup>st</sup>, 1950
- **Rectification Notes:** Image rectified to the UTM Zone 4 North - NAD83 system (via 2<sup>nd</sup> order polynomial w/ an RMS of 3.1m) utilizing visual control points pulled from 2000 DOQQ.
- **Image Notes:** Though beach was photographed in February (winter) it appears to have a fuller width associated with summer months, especially at north end. The vector shoreline (above) used for erosion analysis was drawn from visual high water mark clues from both raw and enhanced versions of the scanned aerial photograph.

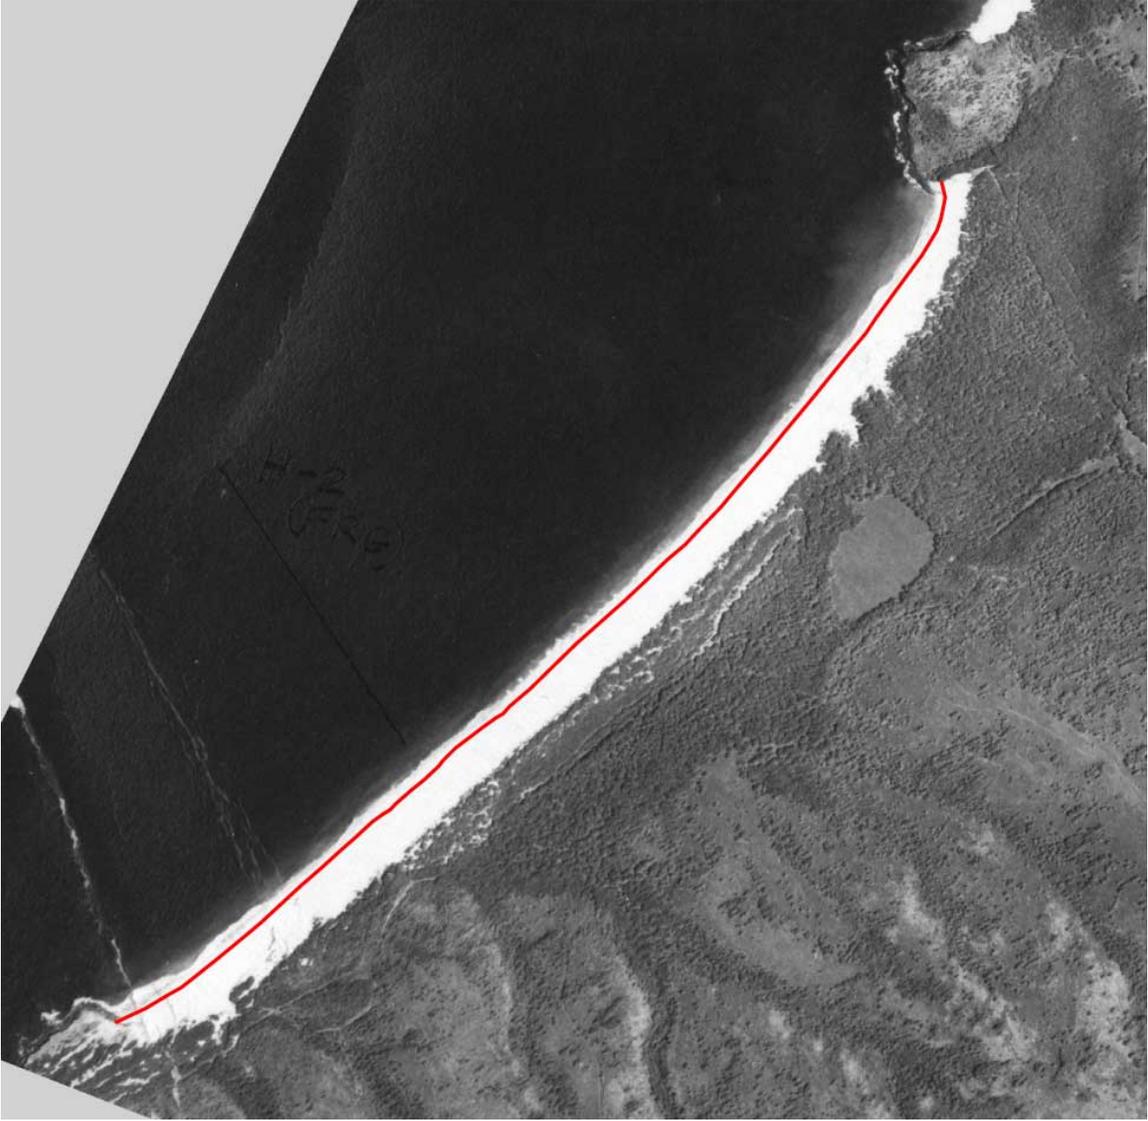
- **Aerial Photograph** - Photo Date: April 28<sup>th</sup>, 1958
- **Rectification Notes:** Image rectified to the UTM Zone 4 North - NAD83 system (via 2<sup>nd</sup> order polynomial w/ an RMS of 3.1m) utilizing visual control points pulled from a 2000 DOQQ.
- **Image Notes:** Fuller beach width – small waves when photo taken. Similar beach structure to 1915 T-sheet. The vector shoreline (above) used for erosion analysis was drawn from visual high water mark clues from both raw and enhanced versions of the scanned aerial photograph.

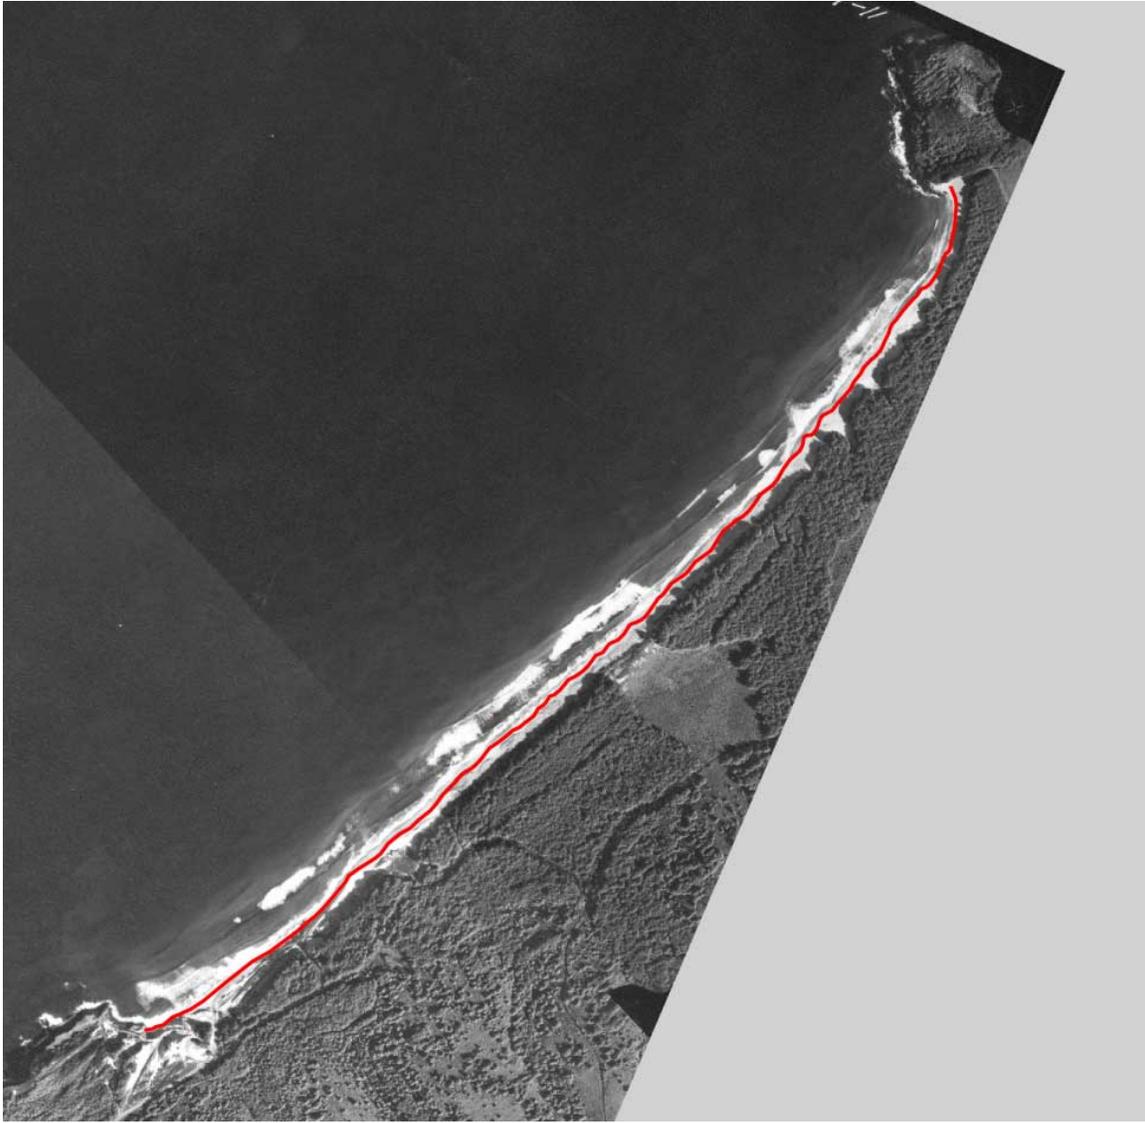
- **Aerial Photograph** - Photo Date: January 7<sup>th</sup>, 1968
- **Rectification Notes:** Image rectified to the UTM Zone 4 North - NAD83 system (via orthorectification w/ an RMS of 4m) utilizing visual control points pulled from a 2000 DOQQ.
- **Image Notes:** Heavy winter seasonal erosion with clear cusping/scarping at time of photo. Active sand mining operations visible at south end of beach. Note: Heavy vegetation shadow line located on beach. The vector shoreline (above) used for erosion analysis was drawn from visual high water mark clues from both raw and enhanced versions of the scanned aerial photograph.

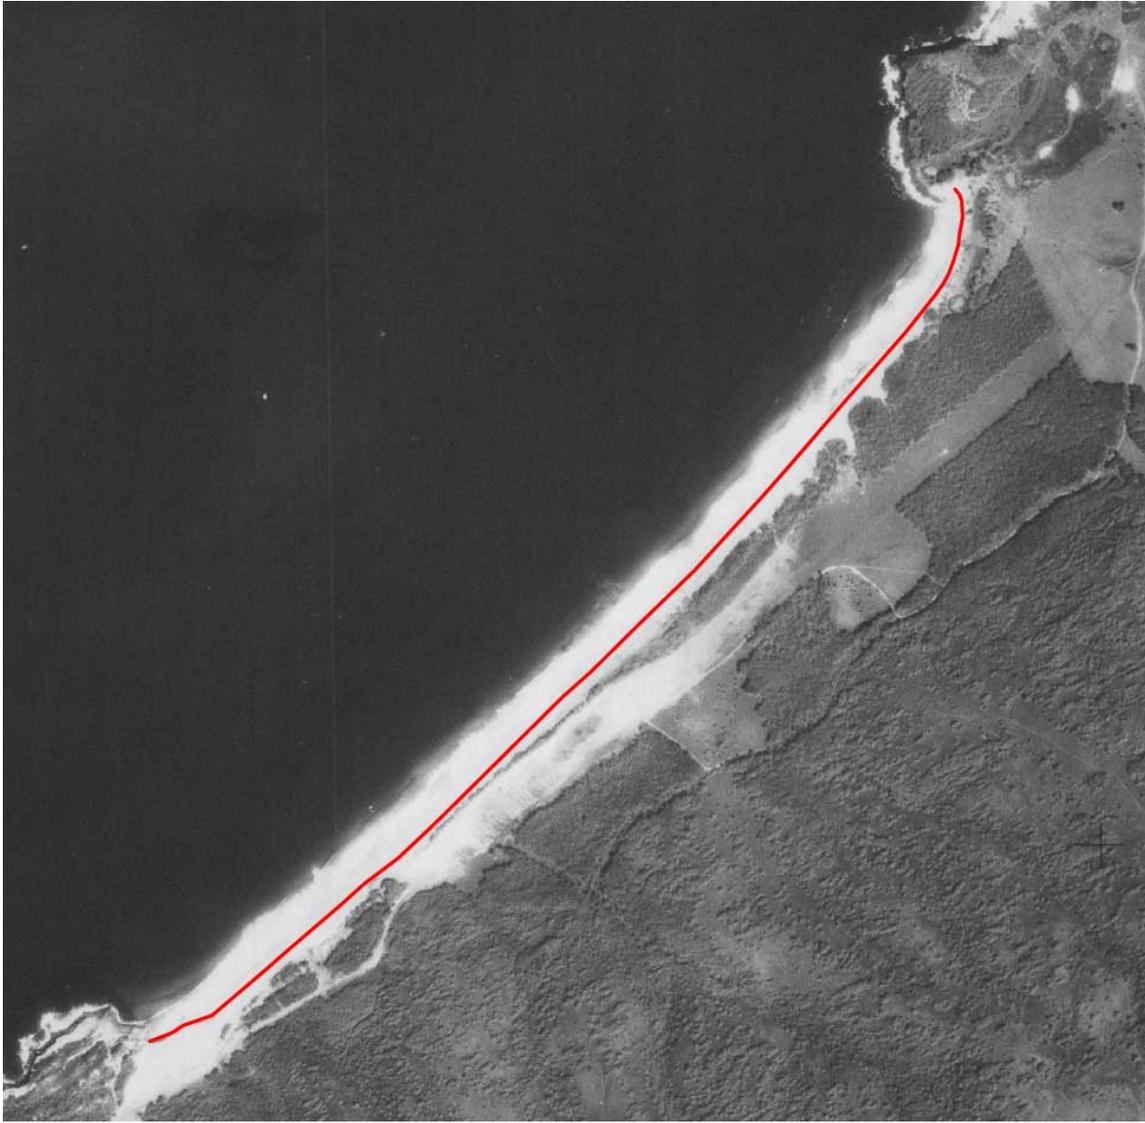
- **Aerial Photograph** - Photo Date: January and March 1977
- **Rectification Notes:** Image rectified to the UTM Zone 4 North - NAD83 system (via 1<sup>st</sup> order polynomial w/ an RMS of 1.3m) utilizing visible graticules. The image is from a scan of an original paper USGS orthophoto product.
- **Image Notes:** Airstrip apparent. The vector shoreline (above) used for erosion analysis was drawn from visual high water mark clues from both raw and enhanced versions of the scanned aerial photograph.

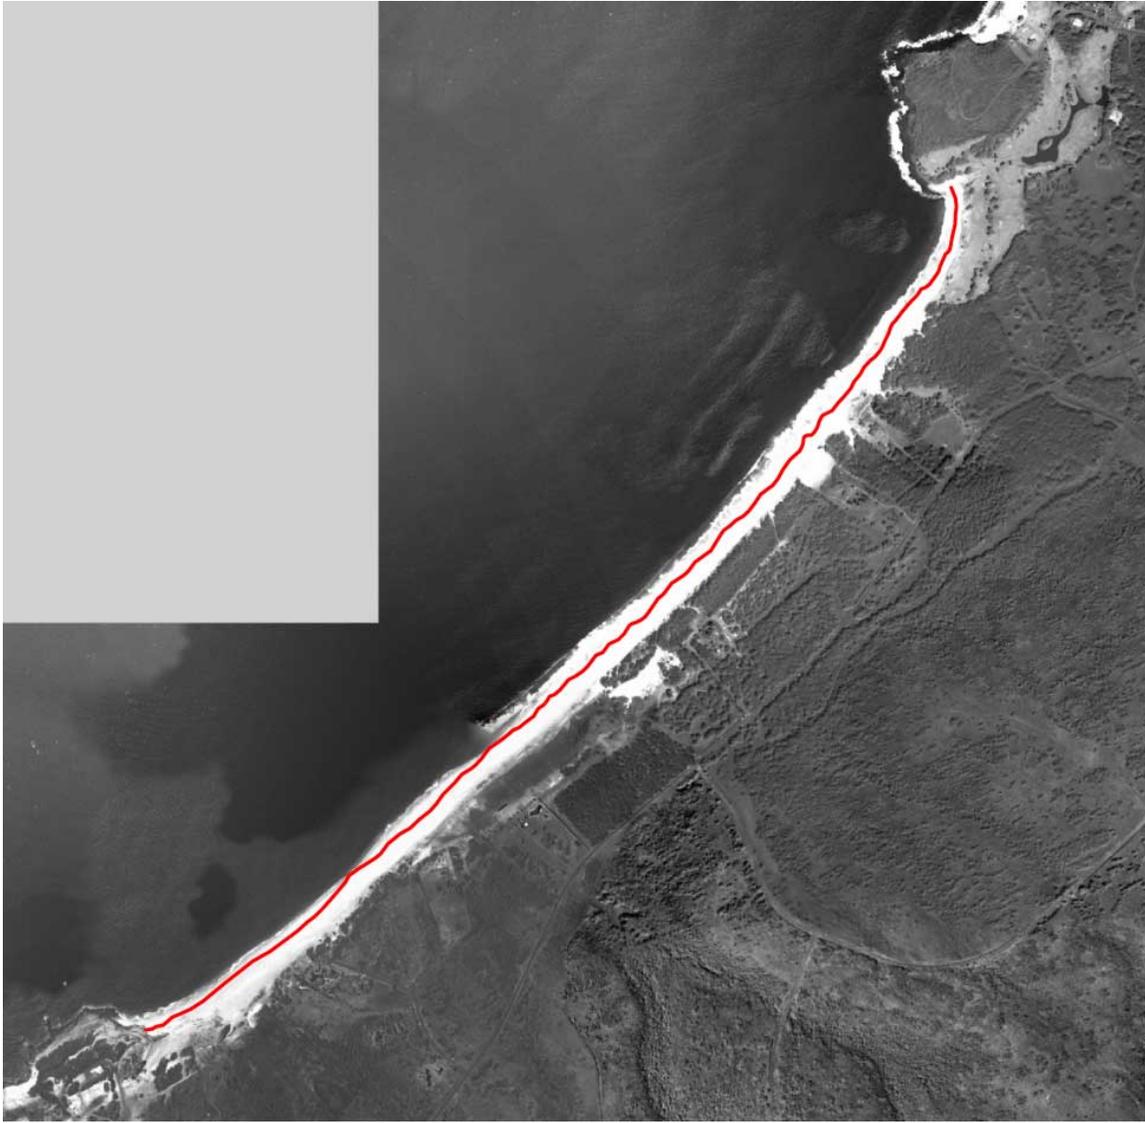
- **Aerial Photograph** - Aerial Photo Date: 2000
- **Rectification Notes:** 2000 DOQQ – this pre-rectified aerial source was taken *as is* and used for both 2000 HWM generation but also a control source used to rectify older aerials in this study.
- **Image Notes:** The vector shoreline (above) used for erosion analysis was drawn from visual high water mark clues from both raw and enhanced versions of the scanned aerial photograph.

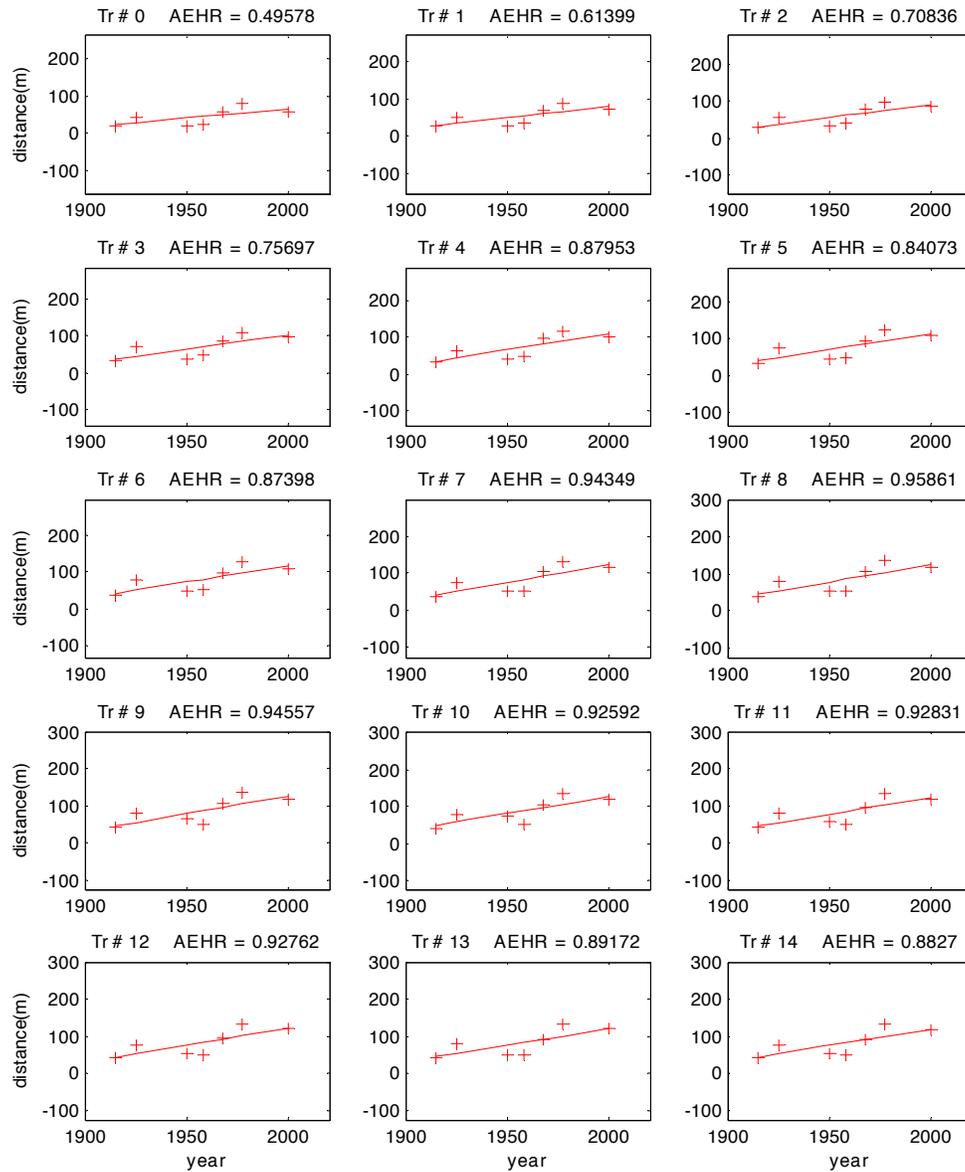
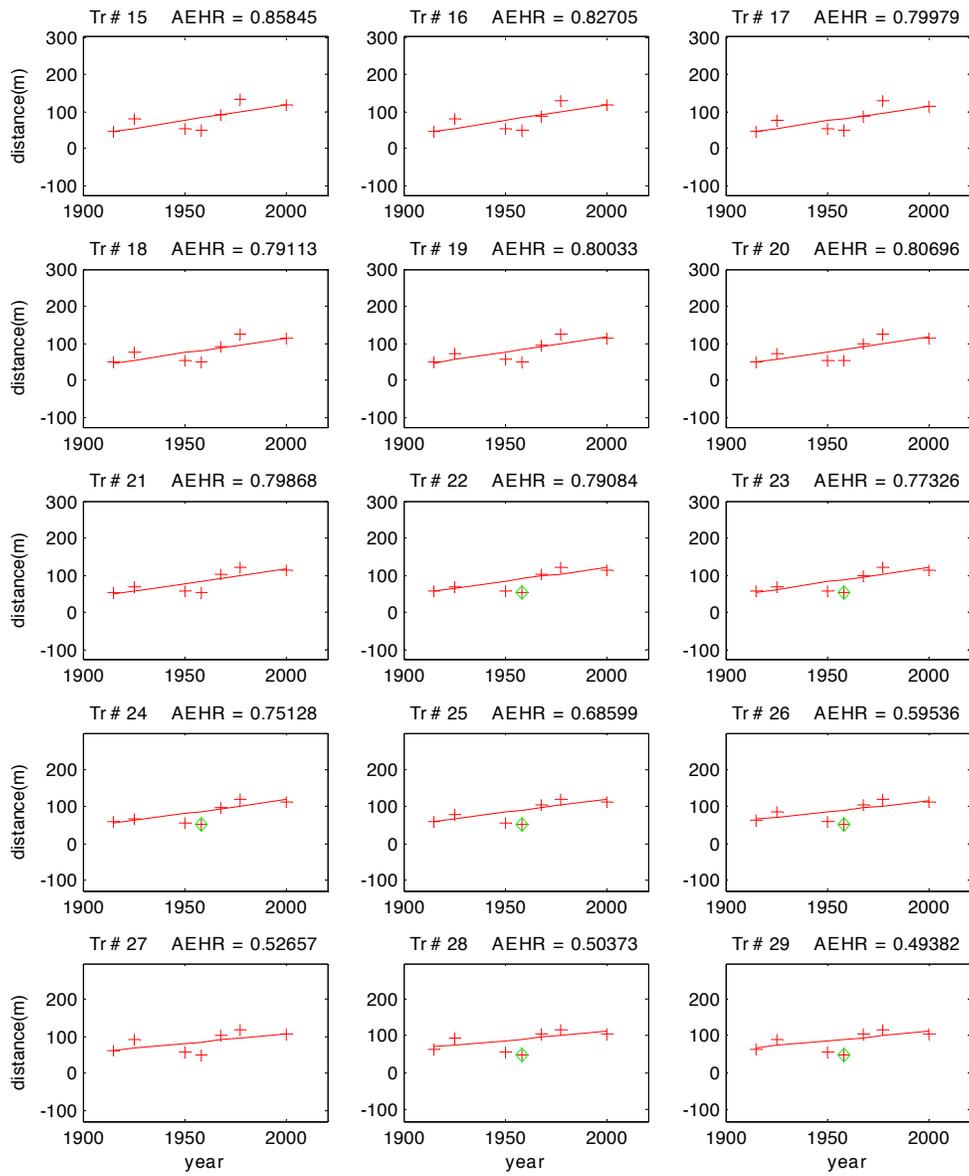
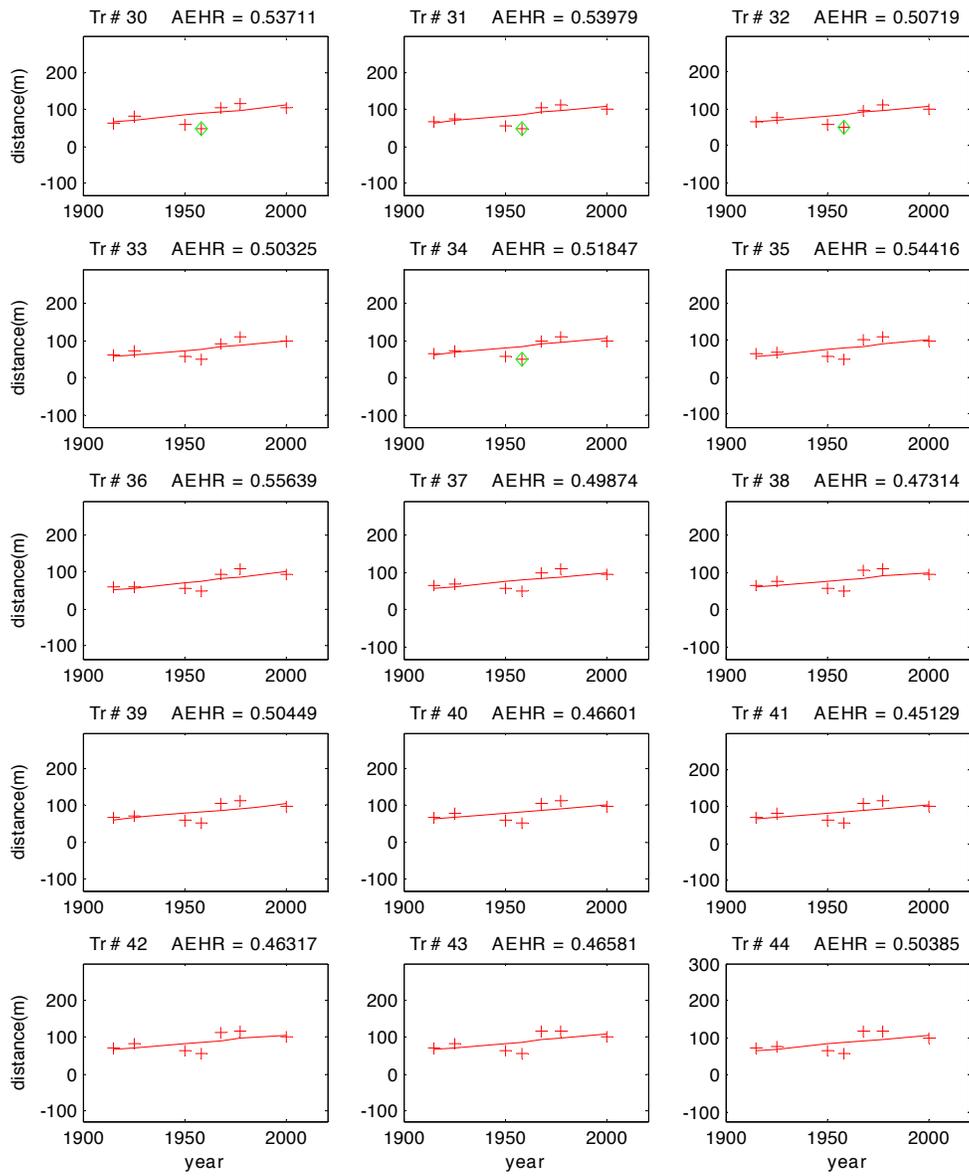
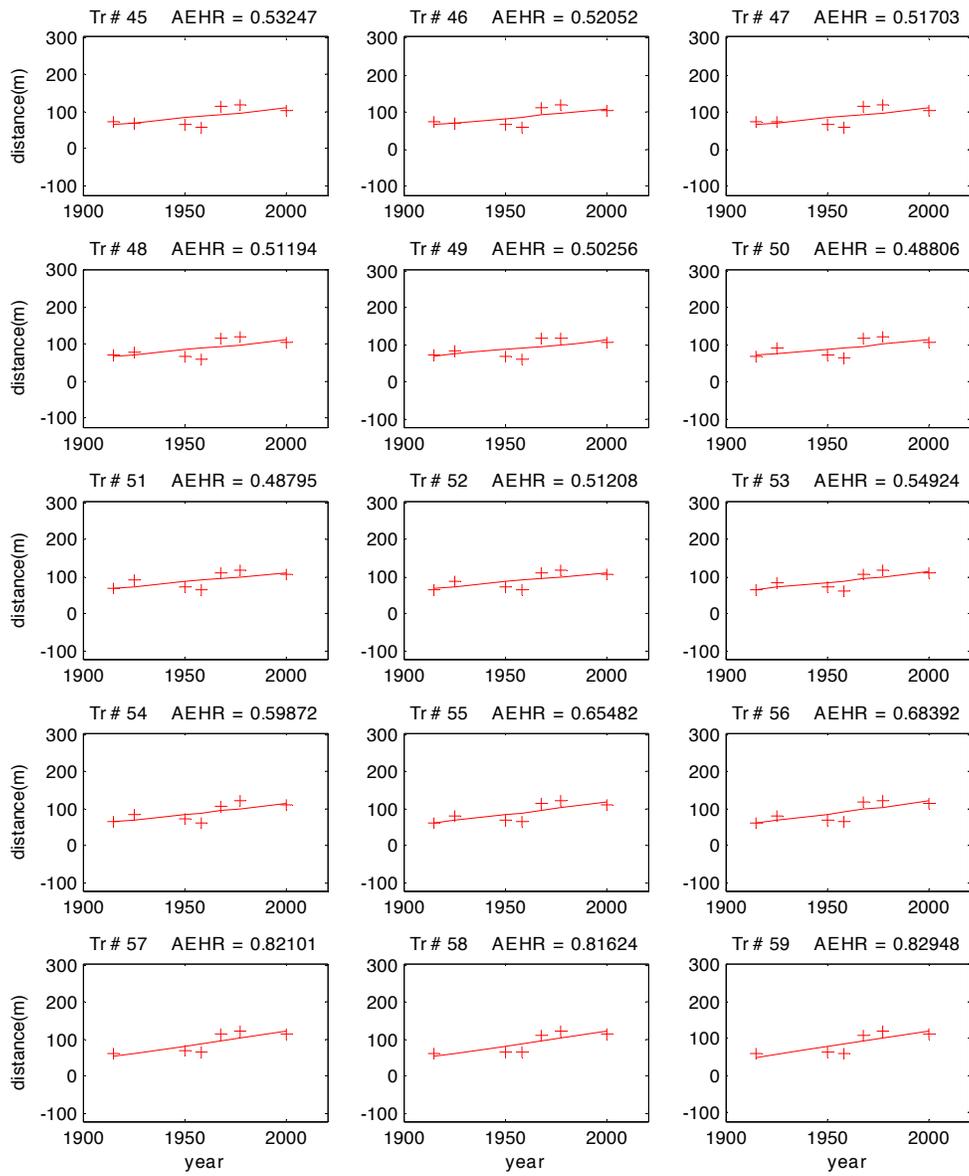
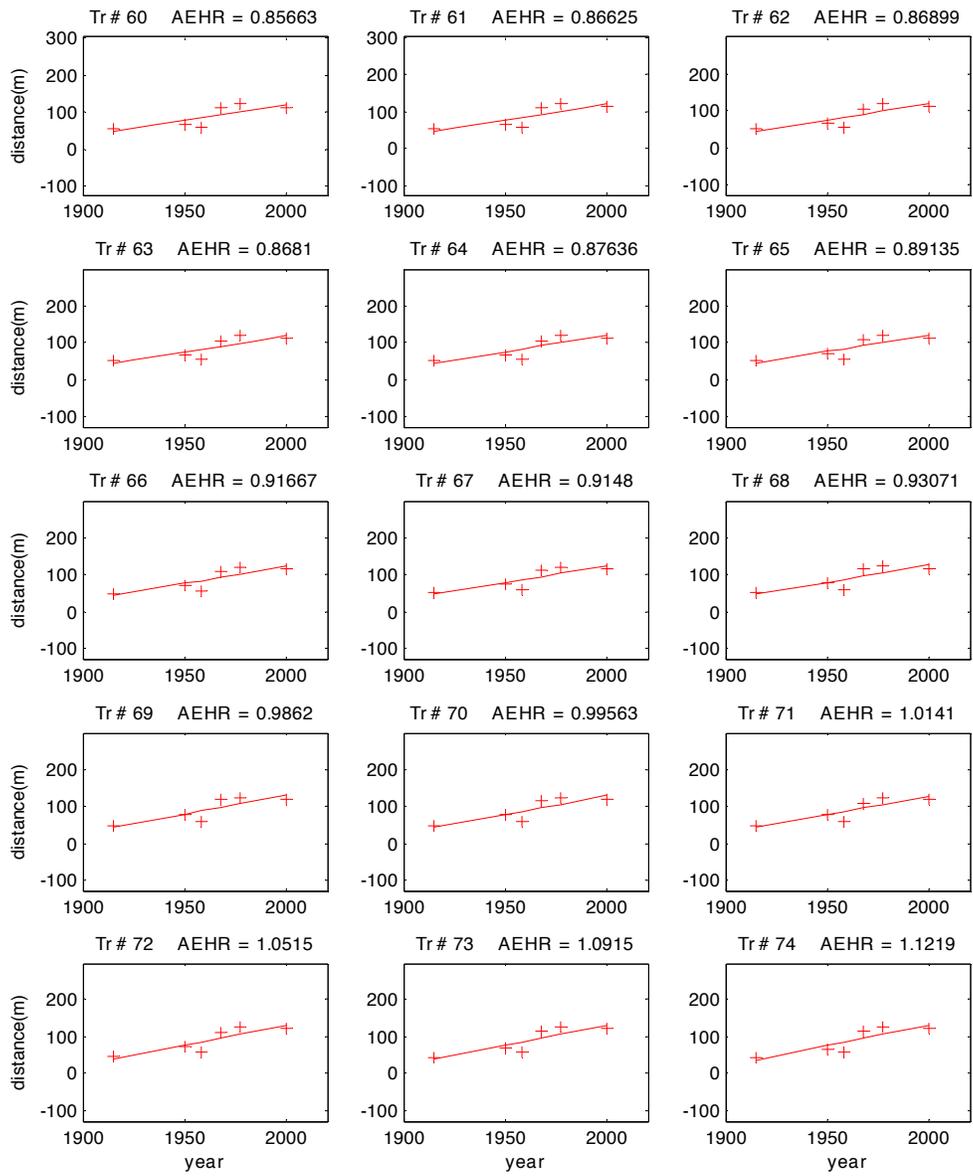
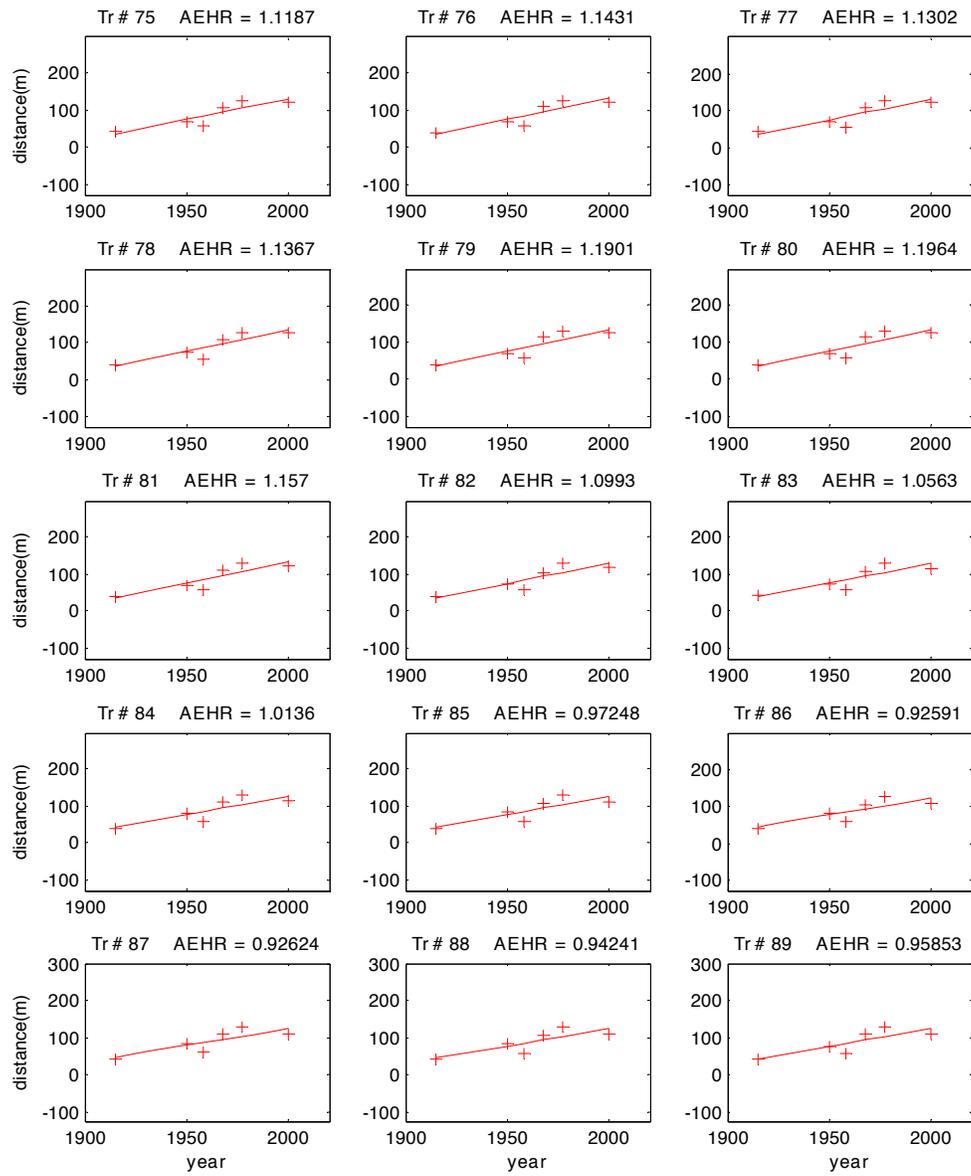
# Annual Erosion Hazard Rate plots (m/yr) for Papohaku Beach transects (156 @ 20m)
