Deep Trouble!

Common Problems for Ocean Observatories

Workshop on Ocean observing infrastructure and sensing –

Technical lessons learned and best practices

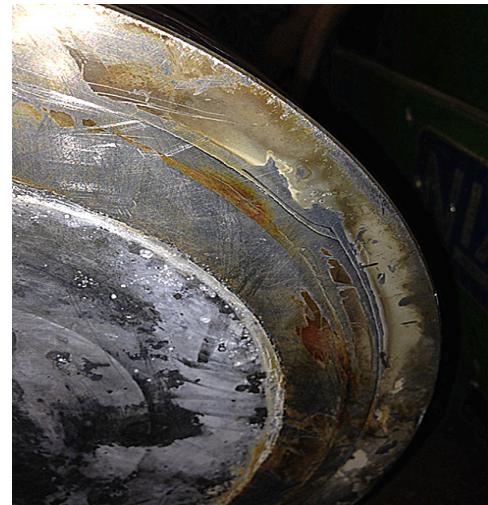
ALOHA, the deepest of the represented cabled observatories at 4728 m, highlighted the challenges of replicating the operational environment during the pre-deployment testing cycle. The observatory suffered failures in instruments that tested correctly at the surface. One sadly spectacular failure was caused by the failure of a stainless steel pressure housing. The metallurgy of the housing led to brittle failure allowing the entire electronics and power suite to be flooded with seawater. This housing was successfully tested to working pressure plus a margin in a freshwater test vessel prior to deployment. It is not known whether additional test cycles, longer duration cycles, different temperatures, and/or testing with saltwater would have uncovered this flaw. The presentation pointed out the need for a standard pressure test program for observatory equipment.

Figure 1: Image showing a crack in the bottom of the pressure housing for the ALOHA MARS Mooring.

Testing that simulates all of the planned deployment environmental factors is desirable as the combination of temperature, pressure and water composition may create unexpected failure modes. The deployment methodology can introduce equipment failures and should be factored into any pre-deployment test plan.

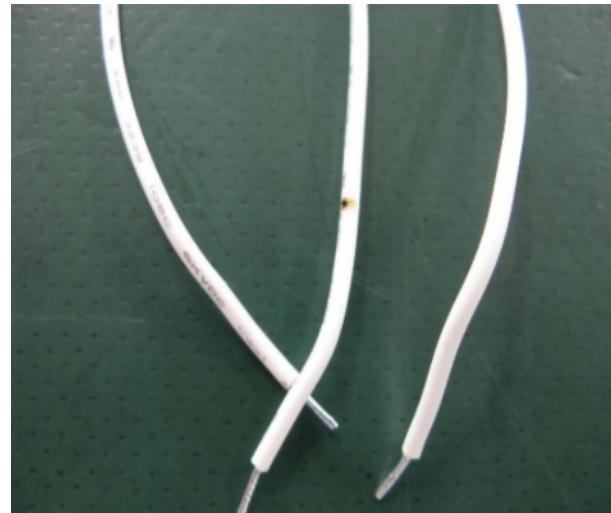
Successful design of the subsea infrastructure for maintainability resulted in very short (10 hr) science node repair time. Cables and connectors have been the weakest elements of the system. A flood tolerant cable assembly that failed due to an insulation fault on one of the internal conductors illustrated the importance of using standard procedures to fully test all elements of a fault tolerant assembly.

Figure 2: Image showing arc perforation (small brown spot) in the insulation of a wire from a flood tolerant connector.

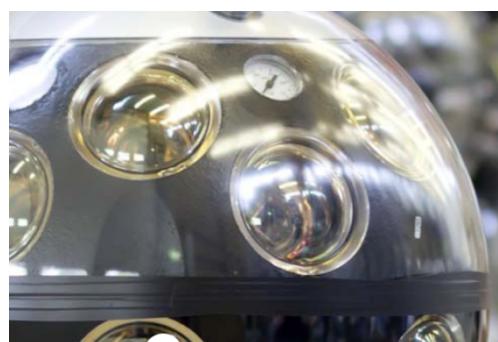
KM3NET is a large scale undersea neutrino telescope. Optical sensors scattered throughout a large and deep volume of Mediterranean seawater detect flashes caused by neutrino interactions. The sensors are connected by a seafloor network at a depth of 3500m. The large water volume of the array and its connecting infrastructure introduces significant planning, deployment and life-cycle maintenance challenges. After initial deployments, maintenance operations uncovered problems that had not been considered in the design. Timely repair of failed infrastructure is difficult since observatory class vessels are typically booked far into the future. The system will ultimately have large numbers of sensors and interconnect nodes and will require an advanced maintenance tracking system.

Figure 3: Photomultiplier tubes in one of KM3NET's sensors,

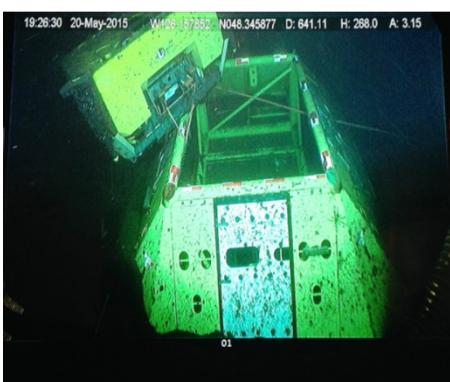
Figure 5: Neptune node after righting from trawl incident.

One spectacular example of the forces ocean observatories have to contend was the trawling of a seafloor node. The node in question was placed in a trawl resistant frame. However, the trawler's wire managed to flip the entire frame. The encased node popped out and complicated the recovery and repair. Given the time required for the recovery of this frame and node, the node design was subsequently simplified to reduce future costs of production and recovery.

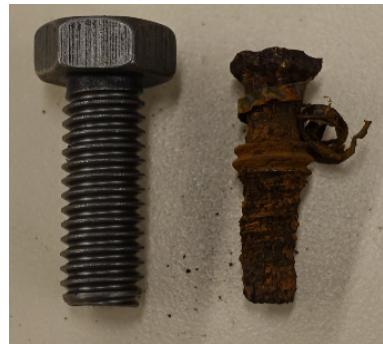
Figure 8: Titanium and stainless steel bolts after a year's deployment.

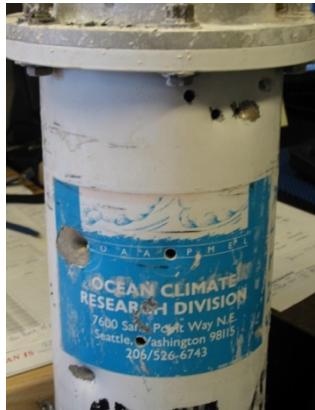
increasing. Aggression types include accidental snagging by fishing gear, fishing gear purposely attached to buoys or use of buoy to assist in fishing, and malicious mechanical destruction,

Figure 11: Bullet holes in science equipment

sometimes by firearms. Data stored in the buoys is often lost. Since the buoys are typically in remote locations, aggression is difficult to prevent or prosecute. A multi-faceted approach is being taken to reduce the

Damage/loss rate. In some cases, video cameras which upload images via satellite have led to a few prosecutions of vandalism. Use of smooth and tough covers which both protect and hide onboard instrumentation has helped. These covers also make it difficult to tie lines to the buoy. Some buoys have been deployed which transmit data via satellite link – thereby eliminating the risk of lost data if the buoys are destroyed.

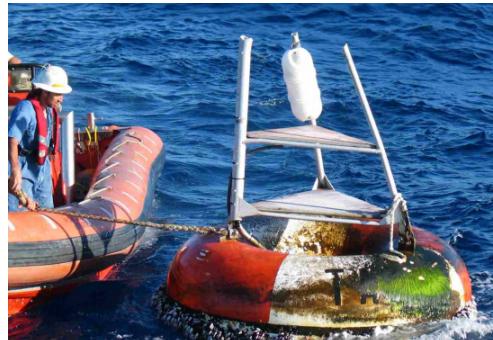
NOAA maintains a large array of observation buoys widely scattered throughout the world's oceans. The buoys collect data and are visited periodically for maintenance and data recovery. Human aggression is a significant source of damage and destruction of this equipment. In the Indian Ocean, between 2004 and 2016, 34 of 148 buoys were destroyed or damaged and the rate of incidence is

Figure 10: Instrument package completely torn off the top of this buoy
