Chapter 10

Armoring on Eroding Coasts Leads to Beach Narrowing and Loss on Oahu, Hawaii

Bradley M. Romine and Charles H. Fletcher

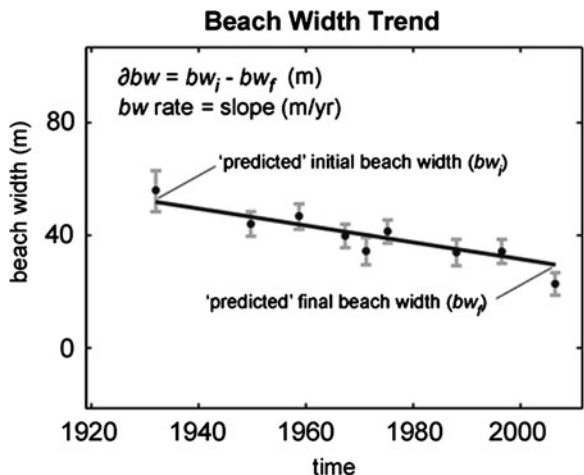
Fig. 10.3 Calculating beach width change with weighted least squares (WLS)

182 Beach width change rates and net beach width change are calculated at each
 183 transect using weighted least squares (WLS) linear regression to fit a trend line to
 184 the time series of measured beach widths. Beach width uncertainties are applied as
 185 weights ($1/Ev - t^2$). Thus, beach widths with higher uncertainty values have less
 186 influence on the trend line. This method is similar to recent studies (Romine et al.
 187 2009; Hapke et al. 2010; Fletcher et al. 2011) – only, beach width data is used
 188 instead of shoreline positions. The annual rate of beach width change (m/year) is the
 189 slope of the trend line (Fig. 10.3). The net change in beach width is the difference
 190 between the estimated beach width values at the end points of the WLS trend
 191 line (at the earliest and most recent shoreline times). Uncertainties of estimated

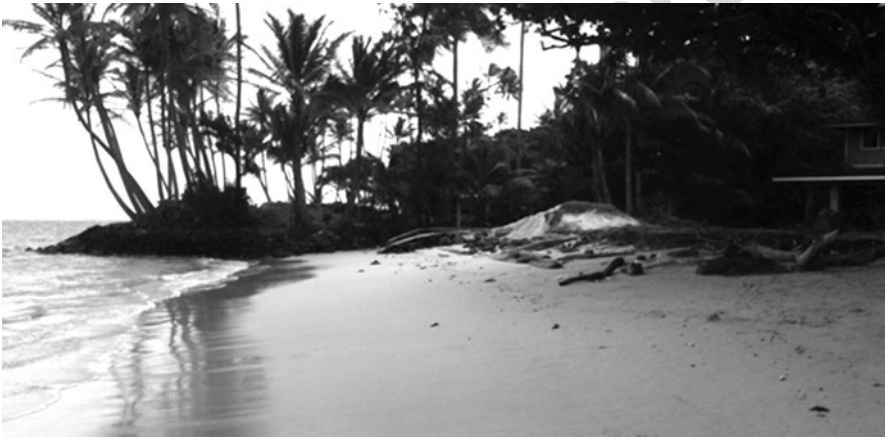
Fig. 10.6 Flanking erosion at Makalii Point (Photo location shown in Fig. 10.5; photo date, March 15, 2011)

270 There is strong evidence that coastal armoring has contributed to accelerated
 271 flanking erosion at Makalii Point following installation of armoring in the 1960s.
 272 Shoreline change rates calculated for the beach immediately north of armoring
 273 installed by 1967 show statistically significant increases in erosion rates (at the 95%
 274 confidence interval) when comparing rates from 1928 to 1967 and 1967 to 2005. As
 275 an example, directly adjacent to the armoring (within Fig. 10.6 photo) the rate
 276 changed from $0.5 + 0.4$ m/year (accretion) to -1.0 ± 0.5 m/year (erosion) follow-
 277 ing installation of armoring. Erosion also increased fronting the northern half of the
 278 1967 armoring, though not to the degree measured on the flanking unarmored
 279 beach. Low rubble revetments were recently (2000s) installed to protect homes
 280 on the north side of the point.

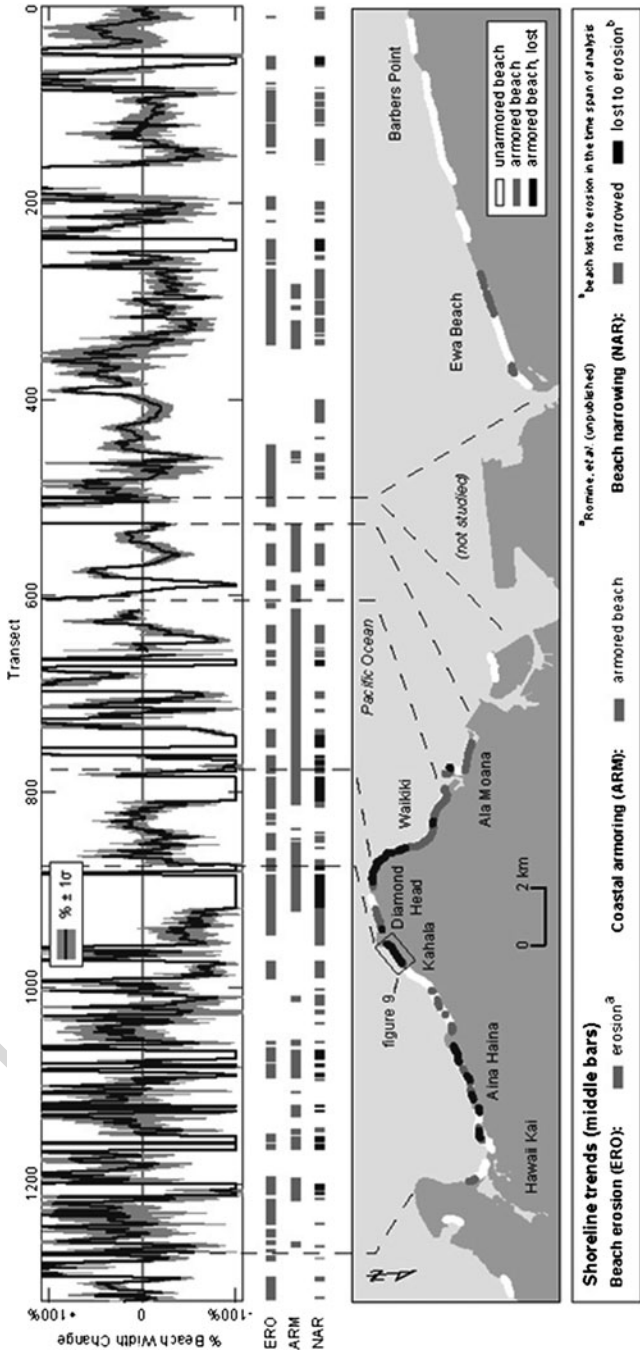
Fig. 10.8 South Oahu beach width percent changes (plot, 1928 or 1949 to near present), shoreline trends (middle bars), and coastal armoring (map)

Along south Oahu (Fig. 10.8), analysis of beach width changes and its relation to shore-parallel coastal armoring is complicated by extensive use of other types of coastal engineering including groins, breakwalls, dredging, and fill – especially along beaches of Hawaii Kai to Kahala and Waikiki. As mentioned previously, beach changes are calculated for the modern configuration of the shoreline following major engineering efforts.

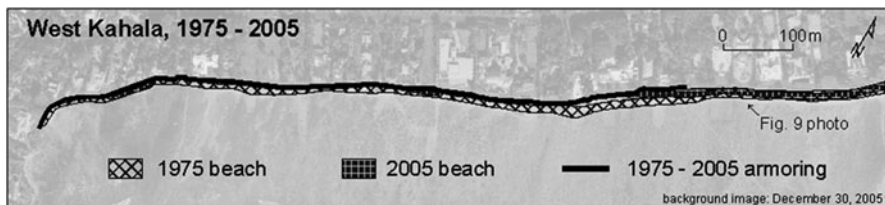
Fig. 10.9 Beach loss at Kahala, south Oahu (1975–2005, location shown in Fig. 10.8)

At the west end of Kahala Beach, roughly 900 m of beach was completely lost to 326
 erosion fronting coastal armoring (Fig. 10.9). Historical changes in the extent of 327
 armoring along west Kahala are difficult to discern from air photos due to dense 328
 cultivated vegetation along seaward property lines. It appears that most or all of the 329
 armoring was constructed prior to 1975 with extensions along a few adjacent 330
 properties in recent years in response to flanking erosion (Fig. 10.10). Analysis of 331
 changes in erosion rates on flanking beaches is not provided for this region due 332
 to the difficulty in mapping armored locations from historical air photos and limited 333
 shoreline data following the installation of armoring. 334

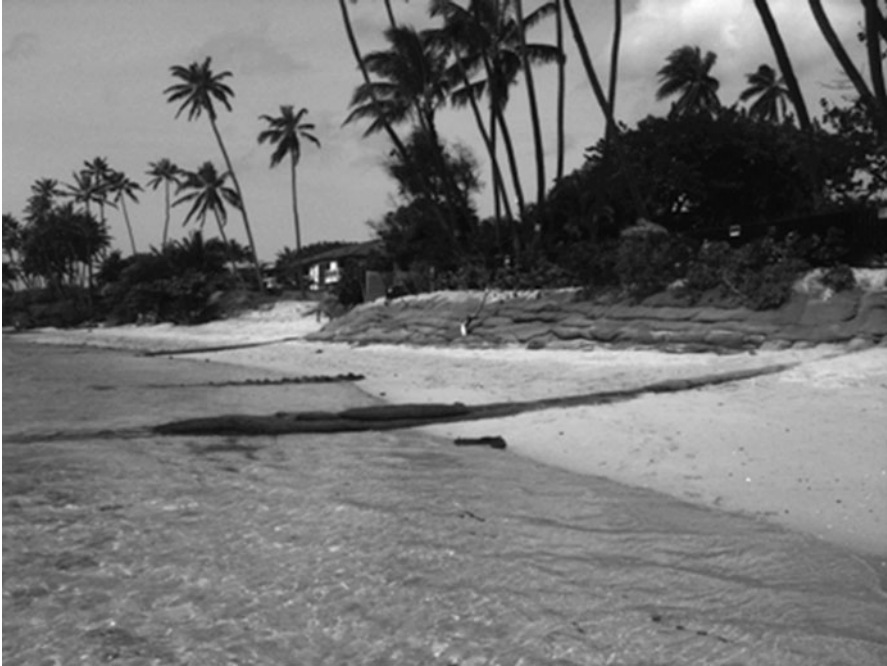
Fig. 10.10 Flanking erosion and temporary armoring (*sand bags*), west Kahala Beach (location shown in Fig. 10.9; photo date, March 21, 2011)

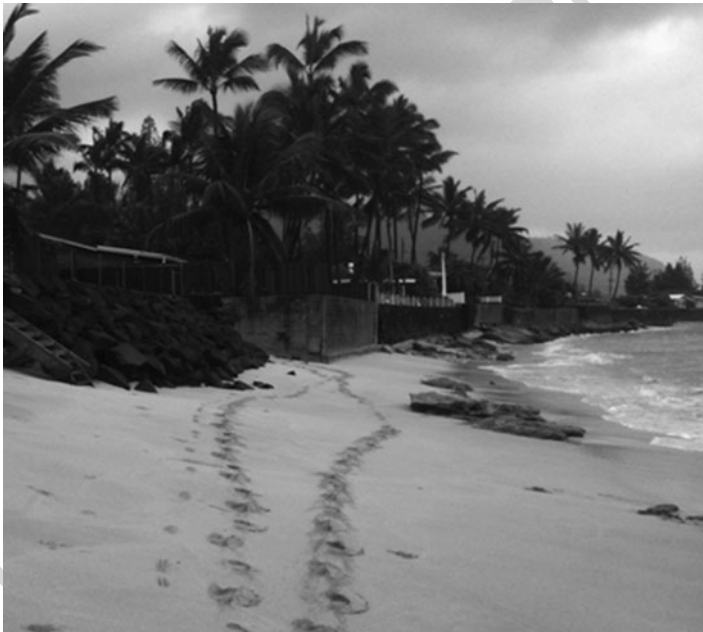
Fig. 10.15 Beach loss at Mokuleia, north Oahu (location shown in Fig. 10.14; photo date March 22, 2011)

374 Beaches are narrowed along most of a continuous beach between Mokuleia and
 375 Waialua, including armored and unarmored sections. Near-complete beach loss is
 376 observed in 2006 air photos of a small embayment at Mokuleia (Fig. 10.14).
 377 Armoring, constructed in the early 1970s, was extended in the 1980s and more
 378 recently to protect coastal properties threatened by flanking erosion. Continued
 379 narrowing has resulted in complete beach loss fronting armoring in the middle of
 380 the bay as observed in a site visit in March of 2011 (Fig. 10.15).
