LANDSLIDES II, VAIONT RESERVOIR, ITALY (21)

II Summary of Vaiont failure

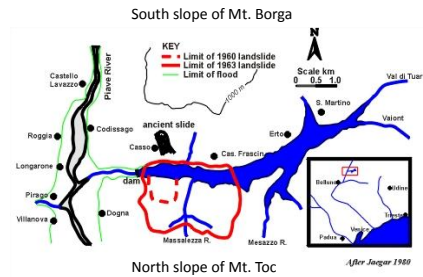
Map of Vaiont reservoir

On October 9, 1963, a landslide with a volume of ~270 million m³ moved into the reservoir behind the recently completed 265m-tall Vaiont dam in Italy - the world's tallest double thin arch dam. The mass moved approximately 500 m at speeds as great as 30 m/sec. It displaced the water in the reservoir (115 million m³ of water prior to failure) and drove a wave up the opposite side of the valley. The wave destroyed the village of Casso, 260 m above lake level, before over-topping the dam by as much as 245 m. An estimated 30 million m³ of water then descended down the valley as a wave initially more than 70 m tall, completely destroying the villages of Longarone, Pirago, Villanova, Rivalta, and Fae. About 2500 people were killed. The dam still stands today: the reservoir slopes failed, but the dam did not. This disaster sparked renewed attention to slope stability around the world. The walls of the valley of the reservoir were particularly susceptible to large landslides: (a) the slopes were steep (~28°), (b) the rock layers dip toward the valley floor, (c) the rock consisted of highly fractured, clay-rich limestone with abundant dissolution features, allowing a well-connected hydrologic system to exist, and (d) the site was the scene of prior large slides in the geologic past. The possibility of a landslide into the reservoir was recognized in advance but estimates of the maximum possible size of a slide underestimated the size of the actual slide by two and one-half orders of magnitude. Surveying measurements and water table (piezometric) measurements made *after* the reservoir began to be filled showed that changes in the reservoir level caused near simultaneous changes in the water table in the valley walls, and that increases in the elevation of the reservoir level corresponded to increased displacement rates of the slide mass on the south valley wall. The failure of the dam can be attributed to inadequate recognition, characterization, and evaluation of the conditions of the slopes flanking the reservoir before and after the reservoir was developed.
