**THE EFFECTS OF MAN-MADE AND CLIMATIC CHANGES ON A TROPICAL
COASTAL SYSTEM: A COMPARATIVE STUDY**

A THESIS SUBMITTED TO
THE GLOBAL ENVIRONMENTAL SCIENCE
UNDERGRADUATE DIVISION IN PARTIAL FULFILLMENT
OF THE REQUIREMENTS FOR THE DEGREE OF

BACHELOR OF SCIENCE

GLOBAL ENVIRONMENTAL SCIENCE

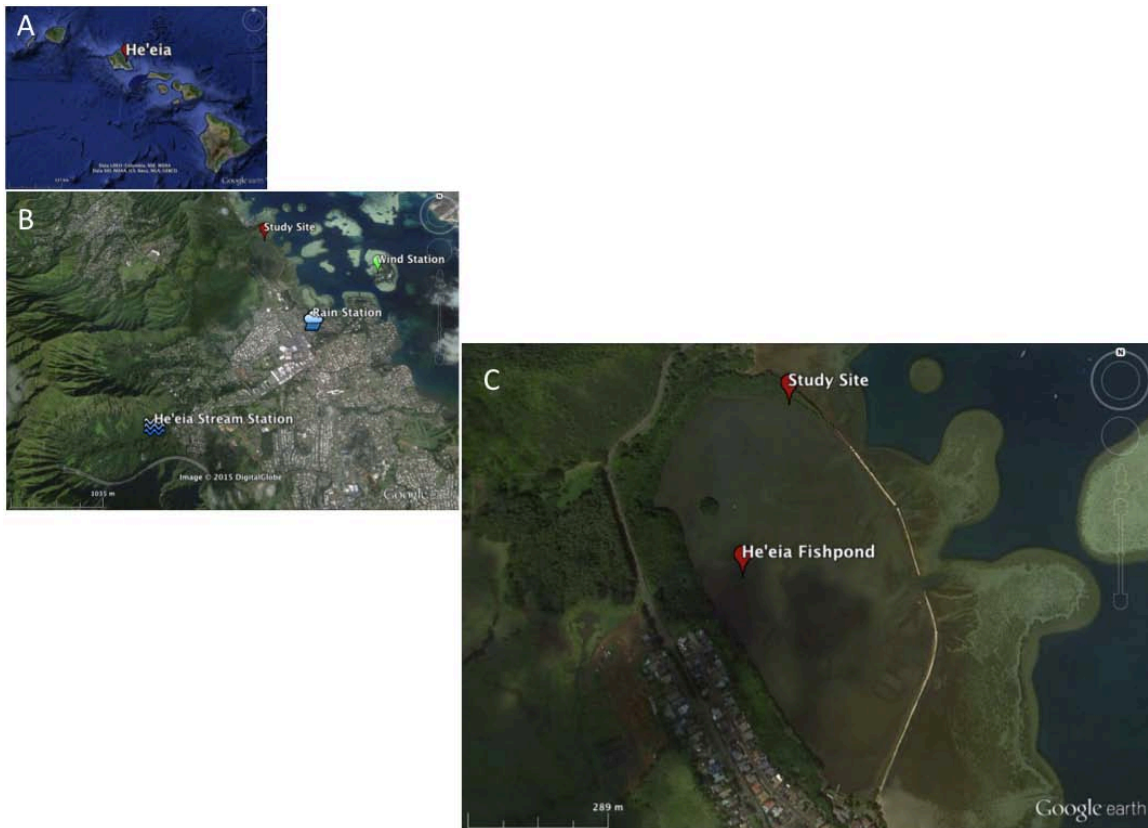
Figure 1. Map of Hawai'i and He'eia Fishpond. A) The main Hawaiian Islands. B) Map of He'eia watershed and Kāne'ohe Bay with location of study site and weather station locations: USGS stream flow station, NOAA rain station and HIMB wind station. C) Map of He'eia Fishpond. (Google Earth, 2015)

The He'eia Fishpond (HFP) is a man-made tropical coastal embayment located in He'eia Uli, at the mouth of the He'eia watershed (Figure 1). The fishpond (*loko i'a*) is built on a fringing reef in southern Kāne'ohe Bay. The watershed drains into He'eia Stream, which flows into Kāne'ohe Bay adjacent to the northern end of the fishpond. Three small tributaries of He'eia stream drain directly into the fishpond. The fishpond is fully enclosed by a semi-permeable *kuapā* (rock wall) that is 1.3 miles long, interspersed with *mākāhā* (gate openings) that allow water exchange with the streams and the adjacent bay (Kāne'ohe Bay) (Figure 2).

He'eia fishpond is located in southern Kāne'ohe Bay, in the district of Ko'olaupoko, on the eastern shore of the Island of O'ahu, Hawai'i (Figure 1). The study site is located 21°26'32" N, 157°48'29" W, in the northeastern corner of He'eia fishpond adjacent to an invasive mangrove patch (Figure 2). The site is pond ward of the edge of a mangrove patch. The site is also adjacent to a large area where mangroves were previously removed (Figure 3). To the east of the study site is an area of fine-grained sediment, where the mangroves were previously topped off but the roots were left behind and still retain sediment. On the western side of the site is an area fully covered by mangroves (Figure 3). The study area is located within the pond adjacent to a 175 m² area of mangroves (Figure 4) targeted for removal during the study. The measured patch of mangrove represents the last stand against the ocean wall in the restoration efforts of mangrove removal.

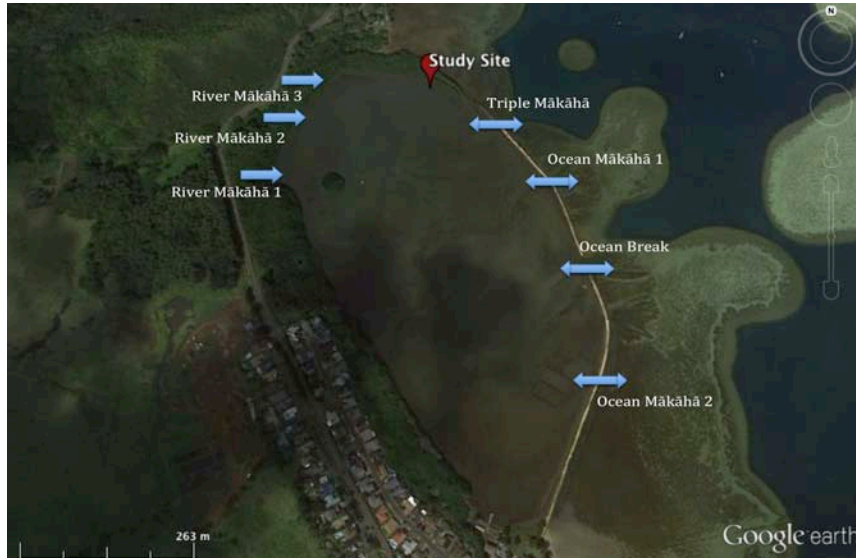
Figure 2. Map of He'eia Fishpond and circulation. Location of gate openings, *mākāhā*, and direction of water flow (blue arrows) (Google Earth, 2015).

Tides: The tides ebb and flow through the *mākāhā*: Ocean Mākāhā 1 (OM1), Ocean Mākāhā 2 (OM2), Triple Mākāhā (TM) and Ocean Break (OB) (Figure 2). During neap tide 33% of the water in HFP is exchanged with Kāne'ohe Bay. During spring tide, 73% of the water in HFP is exchanged with Kāne'ohe Bay. Water exchange also occurs through 3 river Mākāhā (RM1, RM2, RM3) (Figure 2). The major source of freshwater input is through RM2. The northeastern side of the fishpond experiences the largest water exchange, compared to the rest of the pond due to water exchange mainly through TM and OM1. As a result of inputs from both oceanic and freshwater sources the water in the fishpond is brackish (Timmermann et al., in prep.).

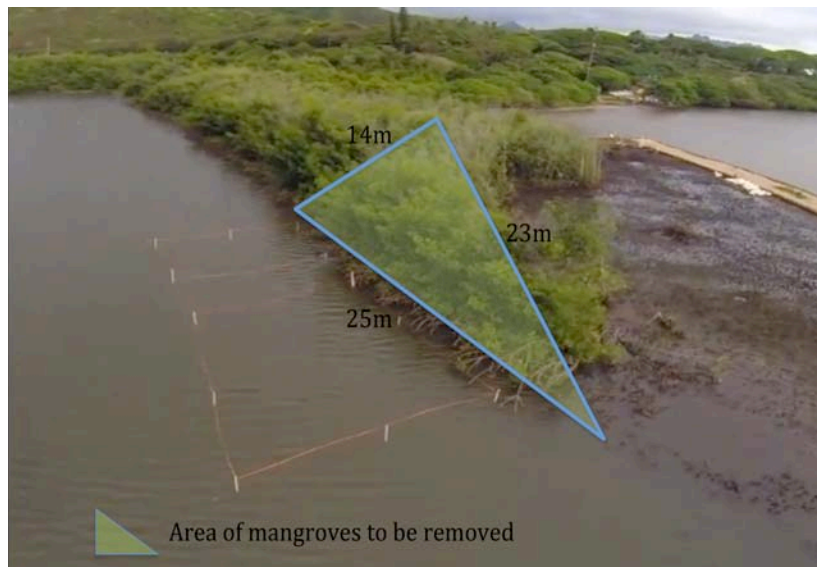
Figure 3. Aerial view of the study site taken on 16 June 2014. Map of the 175 m² mangrove area to be removed (blue triangle), the study site (orange string) and instrument package location (X).

The mangrove patch (Figure 3) was removed in three phases between June 17 and June 30, due to the timing of availability of the volunteer groups. On June 17, 99% of the trees were topped off and 50% of the roots were removed: an 87 m² area of roots above the sediment remained on the side adjacent to the site (Figure 8). On June 27 an additional 18% of roots above the sediment were removed (Figure 9). On June 30, 100% of mangrove roots above the sediment were successfully removed (Figure 10).

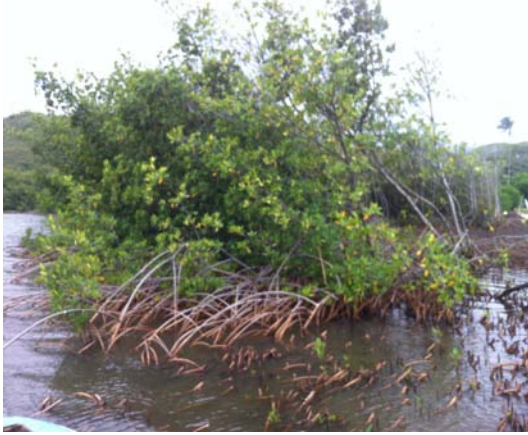
Figure 4. Ground view of a small portion of mangrove patch area to be removed.

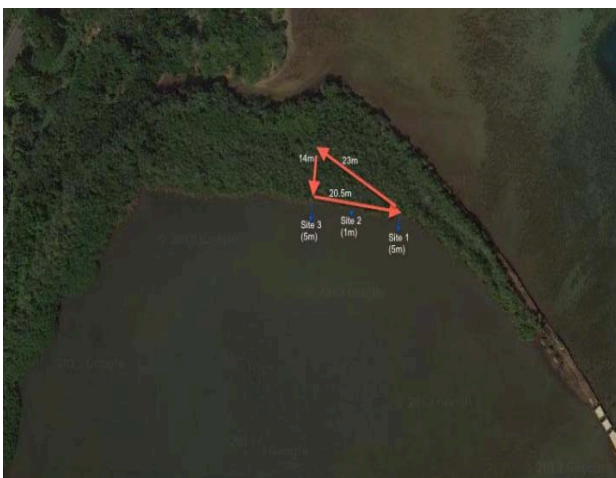
Figure 5. Location of mangrove to be removed.

An initial site survey was conducted on May 9, 2014 to assess the general circulation conditions in the area where the mangroves would be removed and to determine the best location to deploy instrumentation. The mangrove to be removed encompassed a triangular area measuring 14m x 23m x 10.5 (175m²) with the long edge facing the pond (Figures 3 and 5). We deployed a Nortek current meter in 4 different locations along this triangular mangrove patch. Three measurements were taken near the edge of the mangrove patch and one current measurement was taken 1.5 m away from the mangrove patch in the center of our sample area (Figures 5 and 6).

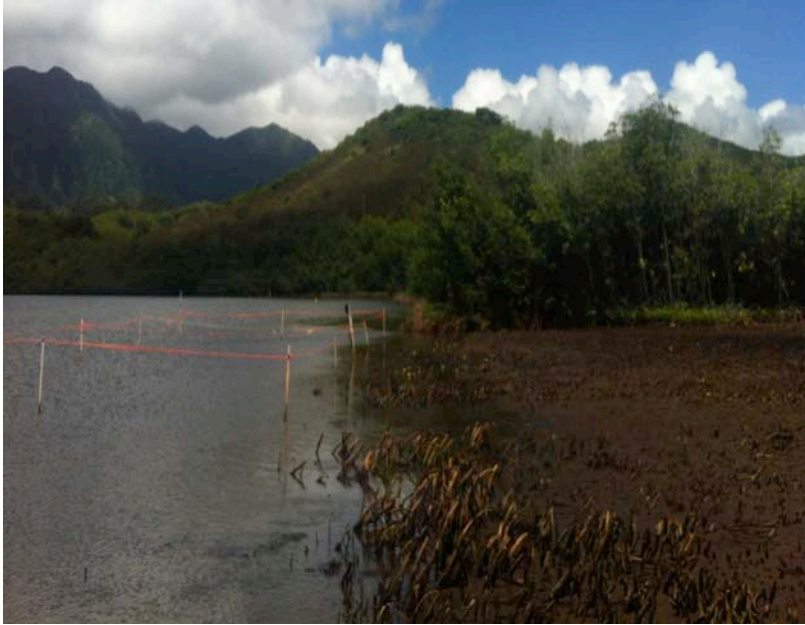
Figure 10. Ground view of study site post-mangrove removal. Mangrove removal phase 3/3, 100% of mangroves removed on June 30, 2014.

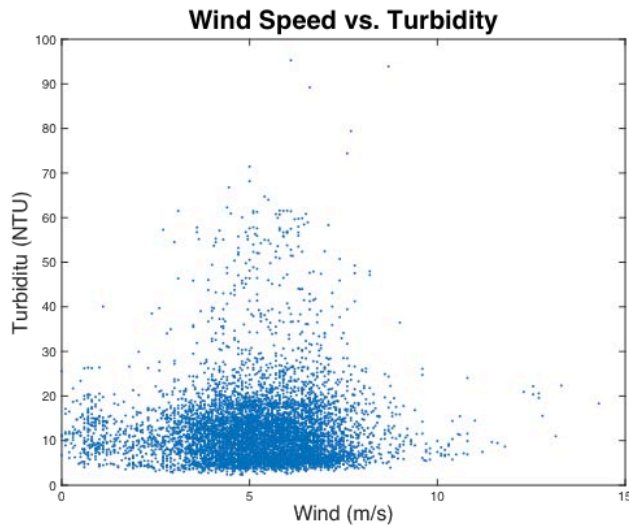
Figure 12. Plot of wind velocity vs. turbidity. Wind speed (m/s) on the x-axis versus turbidity (NTU) on the y-axis.

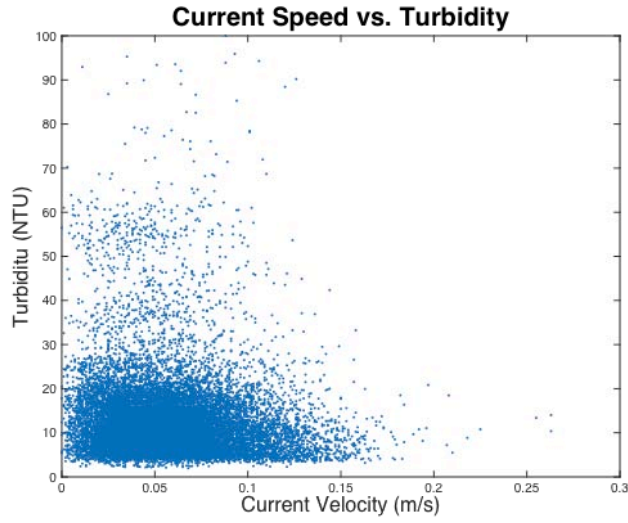
Figure 13. Plot of current velocity vs. turbidity. Current velocity (m/s) on the x-axis versus turbidity (NTU) on the y-axis.

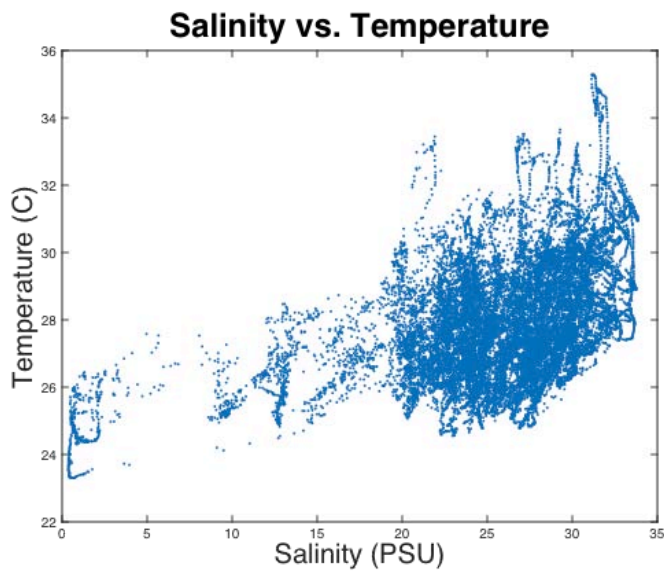
Figure 16. Plot of salinity vs. temperature. Salinity (PSU) on the x-axis versus temperature ($^{\circ}\text{C}$) on the y-axis.

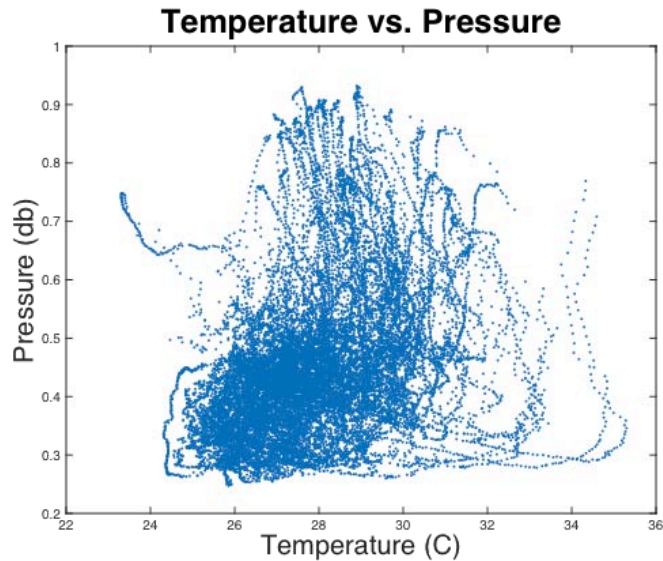
17. Plot of temperature vs. pressure. Temperature ($^{\circ}\text{C}$) on the x- axis versus pressure (db.) on the y-axis.

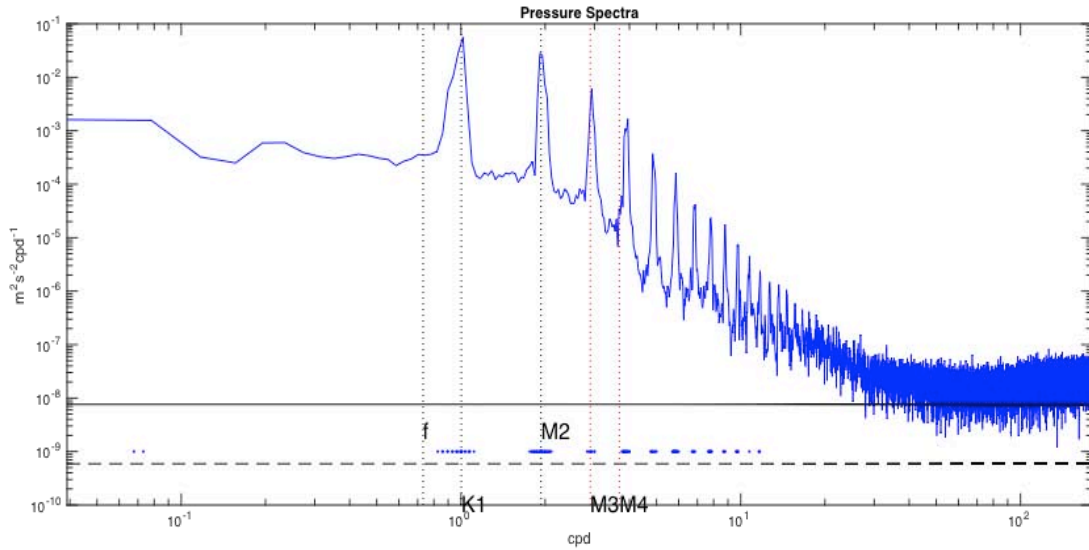
Figure 18. Spectral analysis of pressure. From June 30 – August 15, 2014, with cycles per day on the x-axis and energy ($\text{m}^2\text{s}^{-2}\text{cpd}^{-1}$) on the y-axis. The main tidal harmonic signals are marked f, K1, M2, M3, M4.

Dominant signals in the spectral analysis for pressure are the lunar diurnal constituent frequency ($K1 = 0.98 \text{ d}^{-1}$) and the principal lunar semidiurnal frequency ($M2 = 0.52 \text{ d}^{-1}$) (Figure 18), these correspond to periods of 24.59 hr. and 12.16 hr., respectively (Figure 19). The dominant frequency signals of the currents are $K1 = 0.98 \text{ d}^{-1}$ and $M2 = 0.52 \text{ d}^{-1}$. (Figure 20). Temperature fluctuations occur at periods of 23.05 hr. and 11.89 hr. (Figure 21). Salinity fluctuates at the main periods of 24.59 hr. and 12.16 hr. (Figure 22). Turbidity periodically peaks every 25.15 hr. and 12.26 hr. (Figure 23).

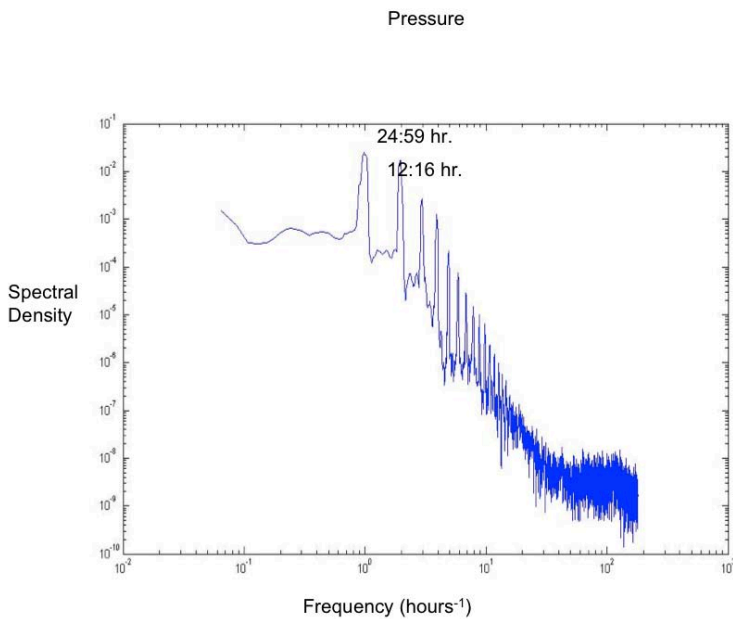
Figure 19. Spectral analysis of Pressure (2). From June 30 – August 15, 2014, with frequency (hours^{-1}) on the x-axis and spectral density on the y-axis. The two main harmonic peaks are marked in hours.

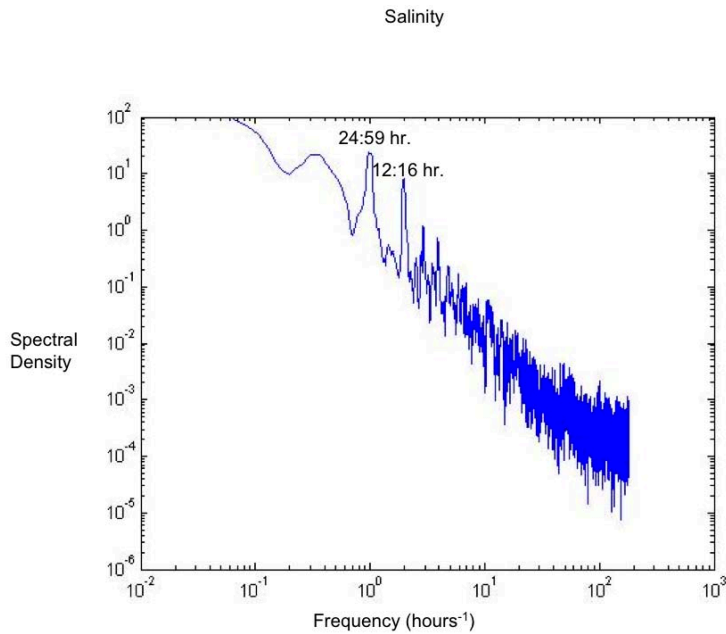
Figure 22. Spectral analysis of Salinity. From June 30 – August 15, 2014, with frequency (hours $^{-1}$) on the x-axis and spectral density on the y-axis. The two main harmonic peaks are marked in hours.

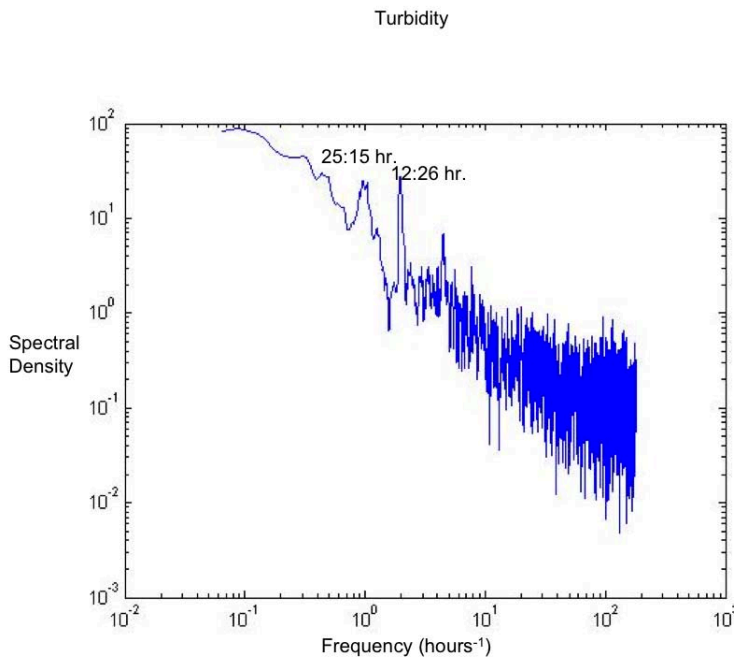
Figure 23. Spectral analysis of Turbidity. From June 30 – August 15, 2014, with frequency (hours $^{-1}$) on the x-axis and spectral density on the y-axis. The two main harmonic peaks are marked in hours.
