SMALL BOAT CRUISE REPORT

VESSEL: *RV Huki Pono*, Cruise AUV1101

OPERATION: Autonomous Underwater Vehicle Optical Surveys

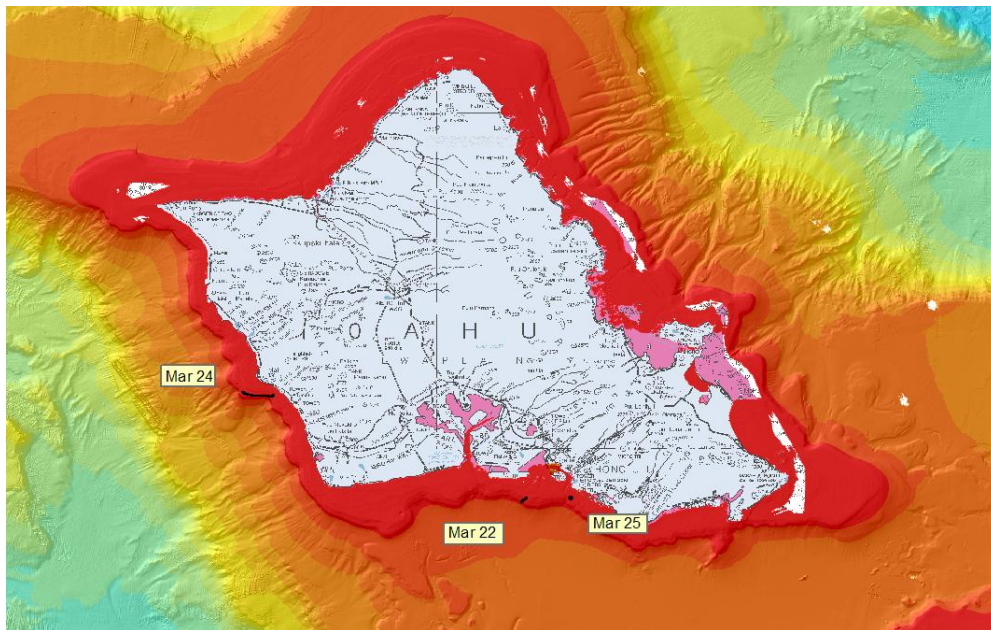
Figure 1: AUV1101 Track Lines
