“Lesson from 5 years continuous operation of DONET cabled observatory network”

Katsuyoshi KAWAGUCHI
Deputy Director

Research and Development Center for Earthquake and Tsunami
Japan Agency for Marine-Earth Science and Technology
(JAMSTEC)

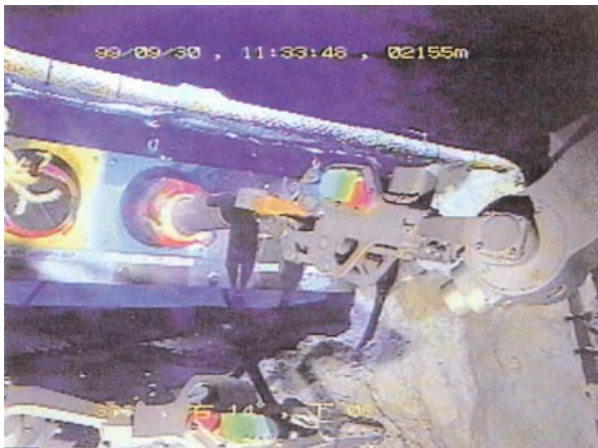
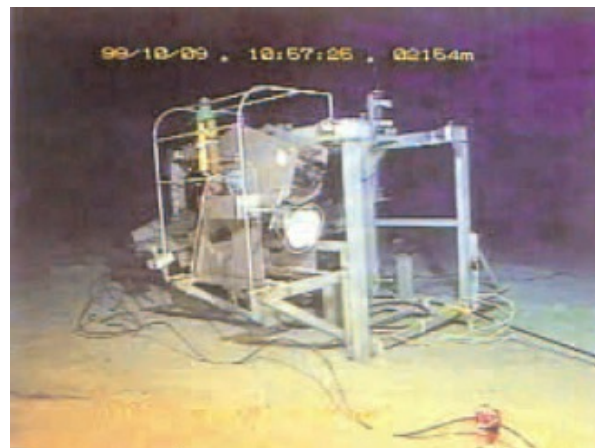
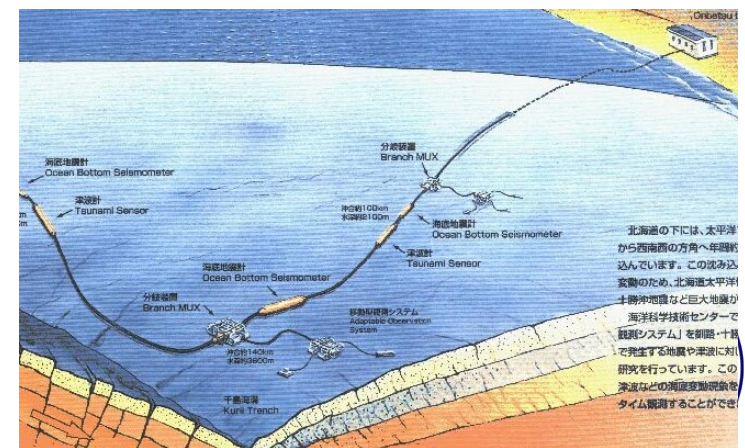
-> VENUS Versatile Ecomonitoring Network by Undersea-cable System (1994-1999 in Japan) ->Node breakdown cause of mold connector twice

->Off Kushiro-Tokachi(1999-) (Adatable Observation System 2000-2003)
Defect of Optic fiber joint box->pressure housing crushed

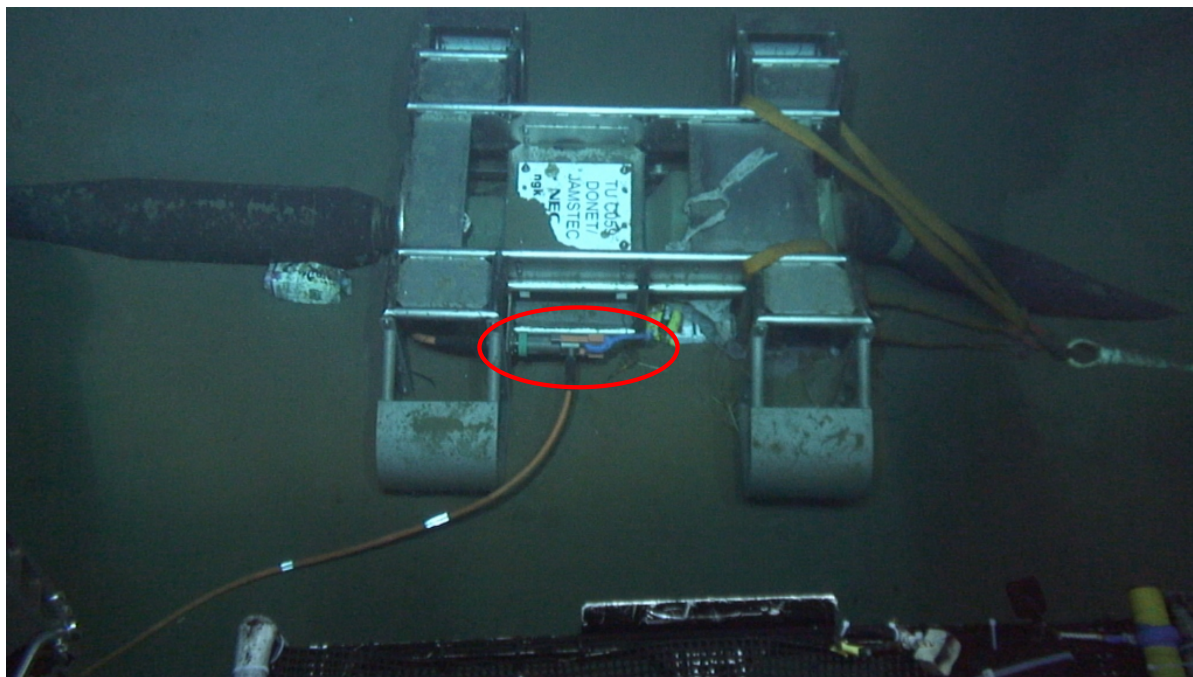
DONET1 TU-E(Terminal Unit)

- Mechanical defect of UMC interface

Ground fault around Site E -> March 6, 2016
Confirmation of Node condition by ROV -> June 8, 2016
