DAM AND RESERVOIR FAILURES (19)

B Teton Dam

GG303

III Teton Dam

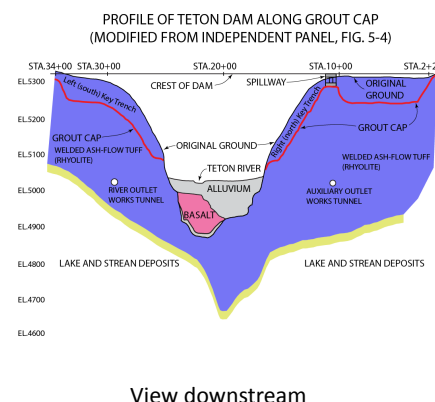
- 1 No grouting of bottom of key trenches above EL. 5025
- 2 Grouting of bottom and walls of cutoff and key trenches left to discretion of contractor
- 3 From EL. 5075 to 5205 joints wider than ~1 cm grouted individually
- 4 Hundreds of joints less than 1 cm wide grouted; some joints 15 cm wide left open
- 5 Sides of key trenches generally not grouted

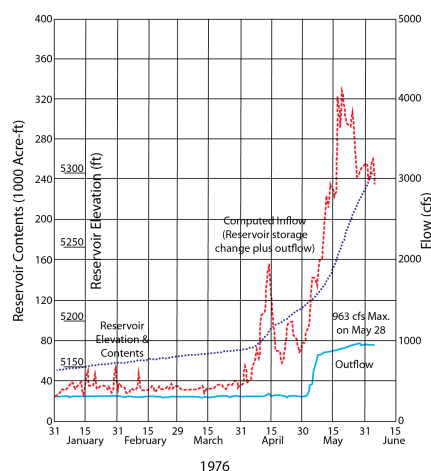
- 1 Filling begun before outlet works operable
- 2 Specified fill rate: 1'/day
- 3 Very heavy snow pack and runoff in 1976
- 4 3/3/76: Fill rate of 2'/day requested
- 5 3/23/76: Fill rate of 2'/day approved
- 6 Mid-May: Fill rate approaches 4'/day
